# Carrickmines-Shanganagh River Flood Relief Scheme

## Otter Conservation Plan

Final Report

August 2026

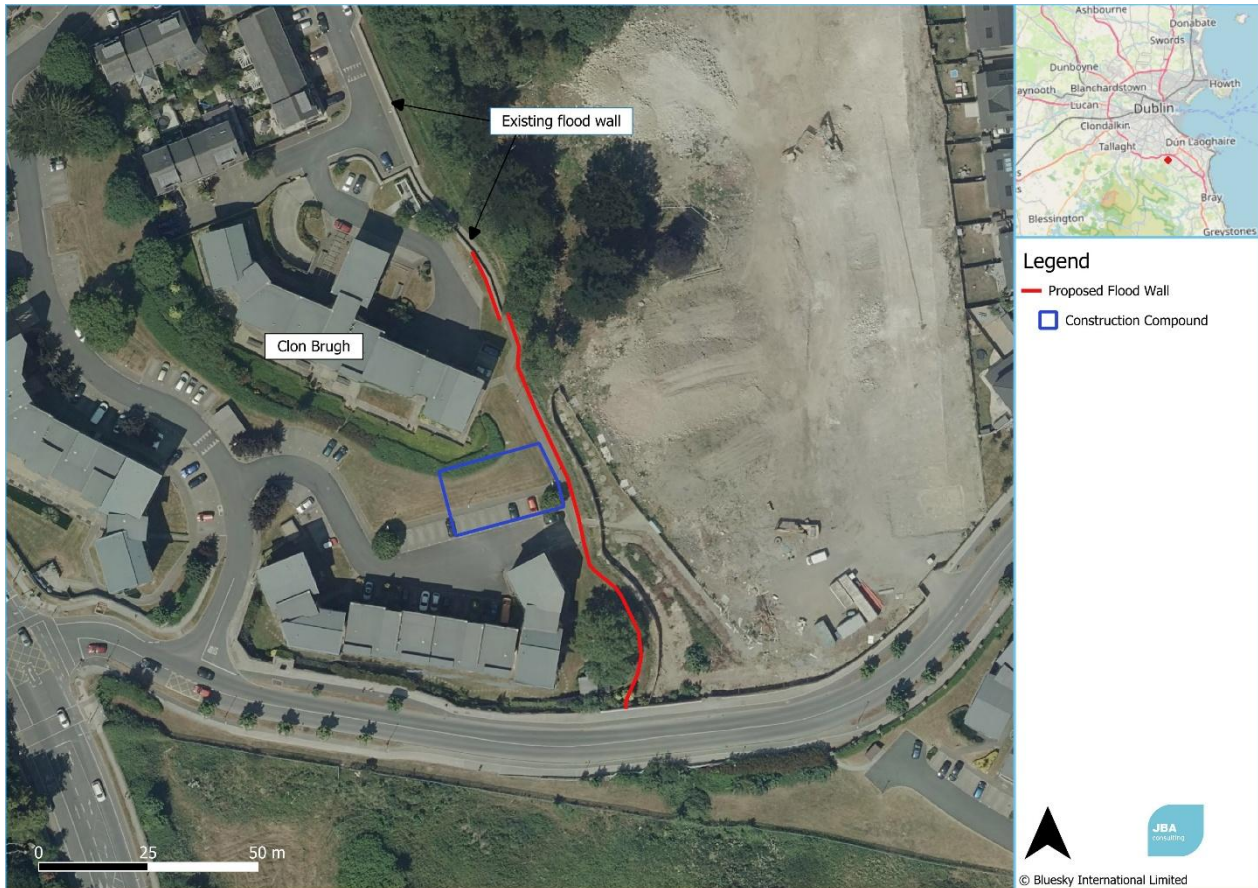
Figure 2-2: Clon Brugh Site Location

Clon Brugh (Figure 2-2) is a residential estate situated just east of the R117 Enniskerry Road. It comprises a mix of 3-4 storey apartment blocks and houses, with small green areas, car parking, and footpaths. The proposed works in this area will be located along an area of linear green space and footpath. The area surrounding Clon Brugh is also primarily residential, with green space to the west and south in the Dublin mountains foothills.

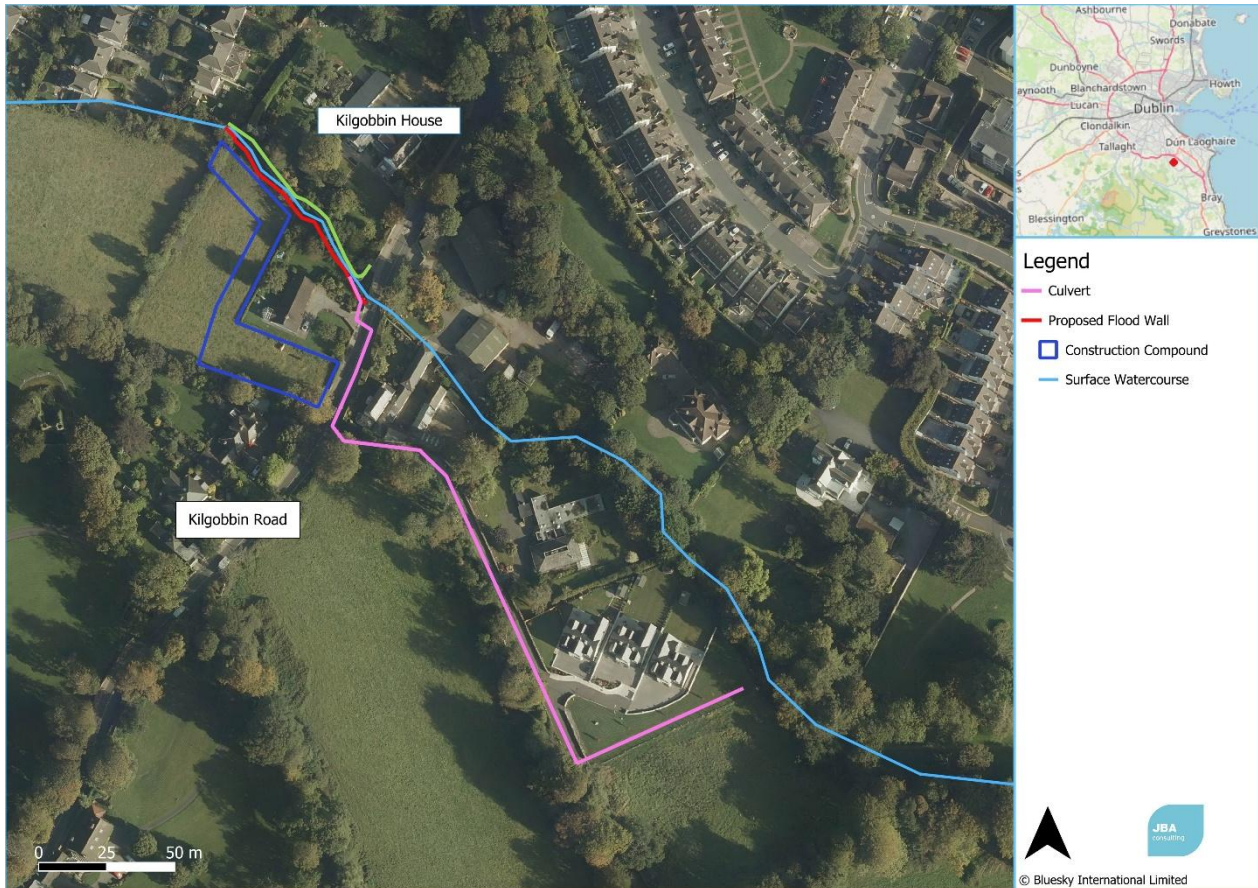
Figure 2-4: Kilgobbin Road Site Location

Kilgobbin Road (Figure 2-4) is a small road lined with trees and stone walls, with a narrow footpath on one side for much of its length. The works in this area will take place along the boundaries of two houses on the western side of the road, before running beneath the road and turning east down a narrow laneway, finally running across an area of open space to join back with the river approx. 220m downstream. The houses in this area are all detached, on large plots of land. Kilgobbin House is a protected structure (RPS No.1684) whose stone wall boundary will be removed and reconstructed as a flood wall.

- Replacement of c.69m of existing stone boundary wall to a protected structure Kilgobbin House (RPS Ref: 1684) and construction of c.100m of stone finished flood defence walls up to c.1.7m upstream of Kilgobbin Bridge.
- Installation of c. 298m of culvert from a proposed flow control weir at Kilgobbin Bridge to a discharge point adjoining Meadowbrook downstream.

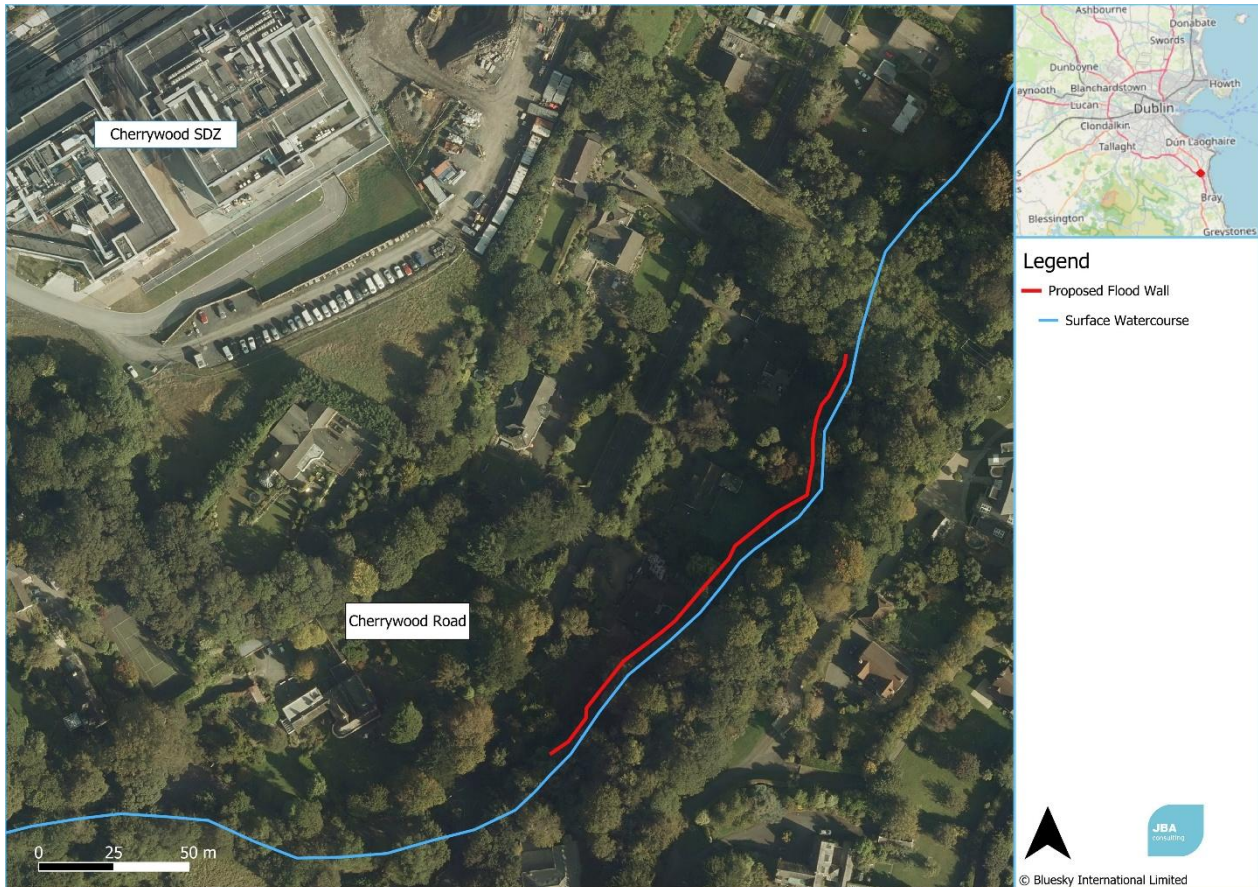
Figure 2-6: Cherrywood Road Site Location

Cherrywood Road (Figure 2-6) is a tree-lined local road with detached houses on either side. It is situated between the M50 to the west and the N11 to the east, with the Cherrywood Strategic Development Zone (SDZ) to the north. Land use in this area is primarily residential, with large green spaces separating individual houses. The proposed works will take place within the property of three houses, adjacent to the river. The river has a riparian corridor here consisting of mature trees and other vegetation. Immediately downstream of this point, the river flows beneath the Cherrywood Viaduct, which is a protected structure (RPS No. 1783).

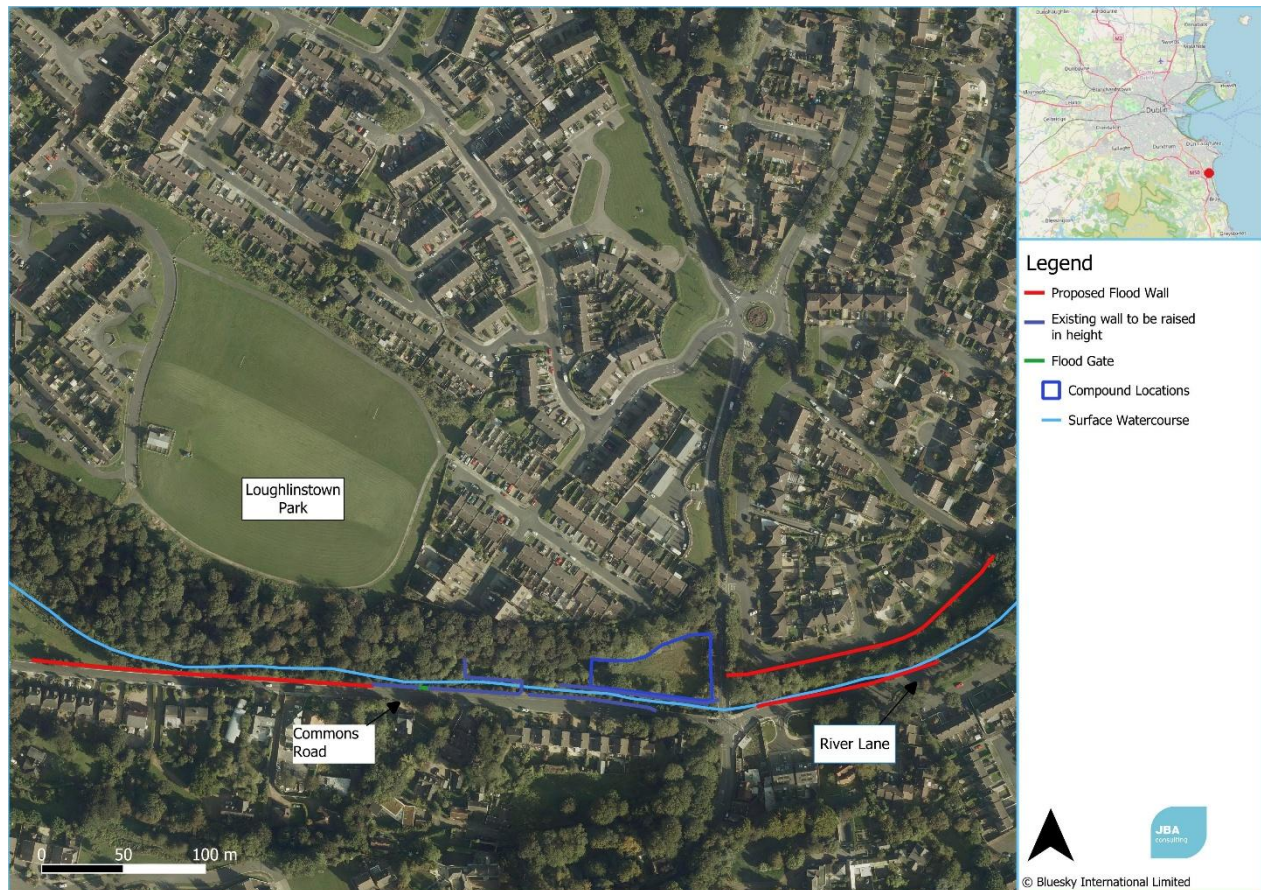
Figure 2-8: Commons Road, River Lane and Brookdene Site Location

Works at the Commons Road, River Lane and Brookdene Site Location (Figure 2-8) will take place along the Shanganagh River as it flows from west to east along Commons Road, under the Shanganagh Road Bridge, and between Shanganagh Wood and Brookdene. Upstream of the bridge, Commons Road has residential development along its south side, with the river adjacent to the north. The northern side of the river at this point is wooded, with one house and a bridge providing access at roughly the midway point of the works. North of the wooded area is housing. Shanganagh Road Bridge is a protected structure (RPS No. 1772) and is a narrow two-lane stone arch bridge. Downstream of the bridge, Shanganagh Wood and Brookdene are both residential roads, with a footpath adjacent to the river along Shanganagh Wood, and a riparian strip and tree line on the left (north) bank at Brookdene.

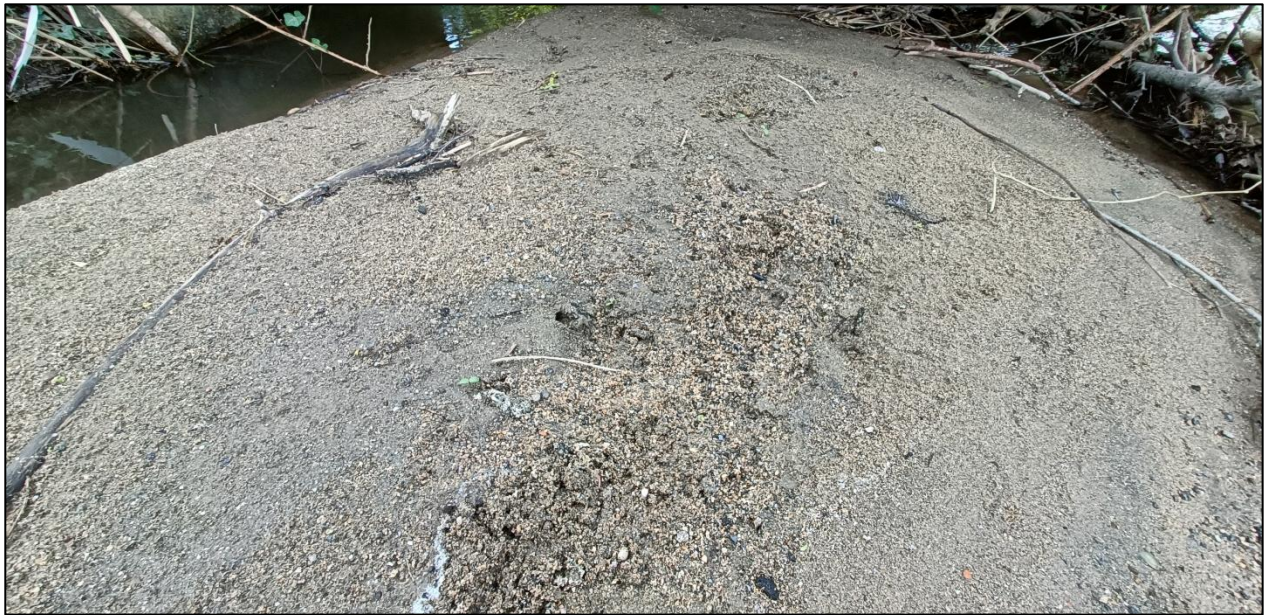
A single sign heap, the term used to describe locations where Otter scrap up small piles of vegetation, silt/sand and spraint upon or adjacent to them, was recorded downstream of the Bayview works area. This sign heap was located in-channel on a sandy dispositional bar, with two spraints located immediately adjacent to the heap and claw scratchings in the sand.

Figure 5-1: Otter sign heap with spraints (centre left by seedling) downstream of Bayview works area

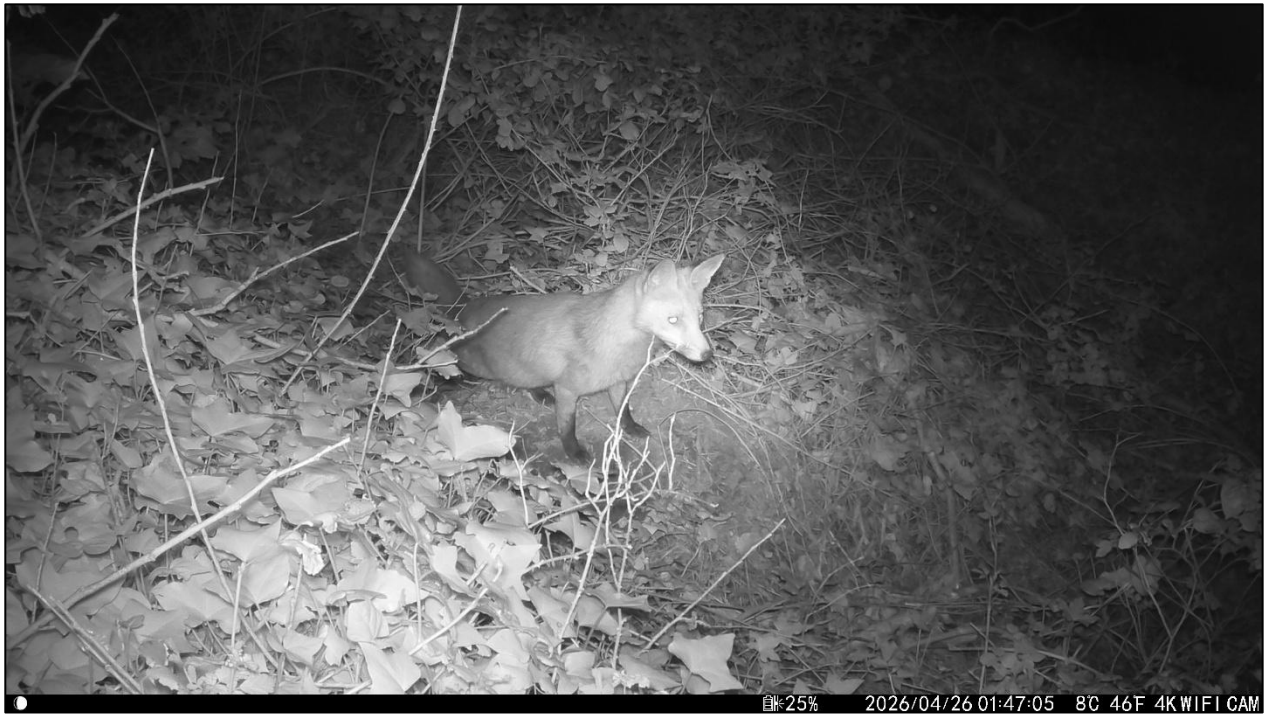
A potential two-entrance Otter holt, with an accompanying slide into the river, was discovered along the right bank of the Shanganagh River downstream. This potential holt was in close proximity to the in-channel sign heap and spraints.

Monitoring of the potential holt revealed that it was currently being utilised by Red Fox (Figure 5-2).

Figure 5-2: Red Fox emerging from the potential two-entrance holt

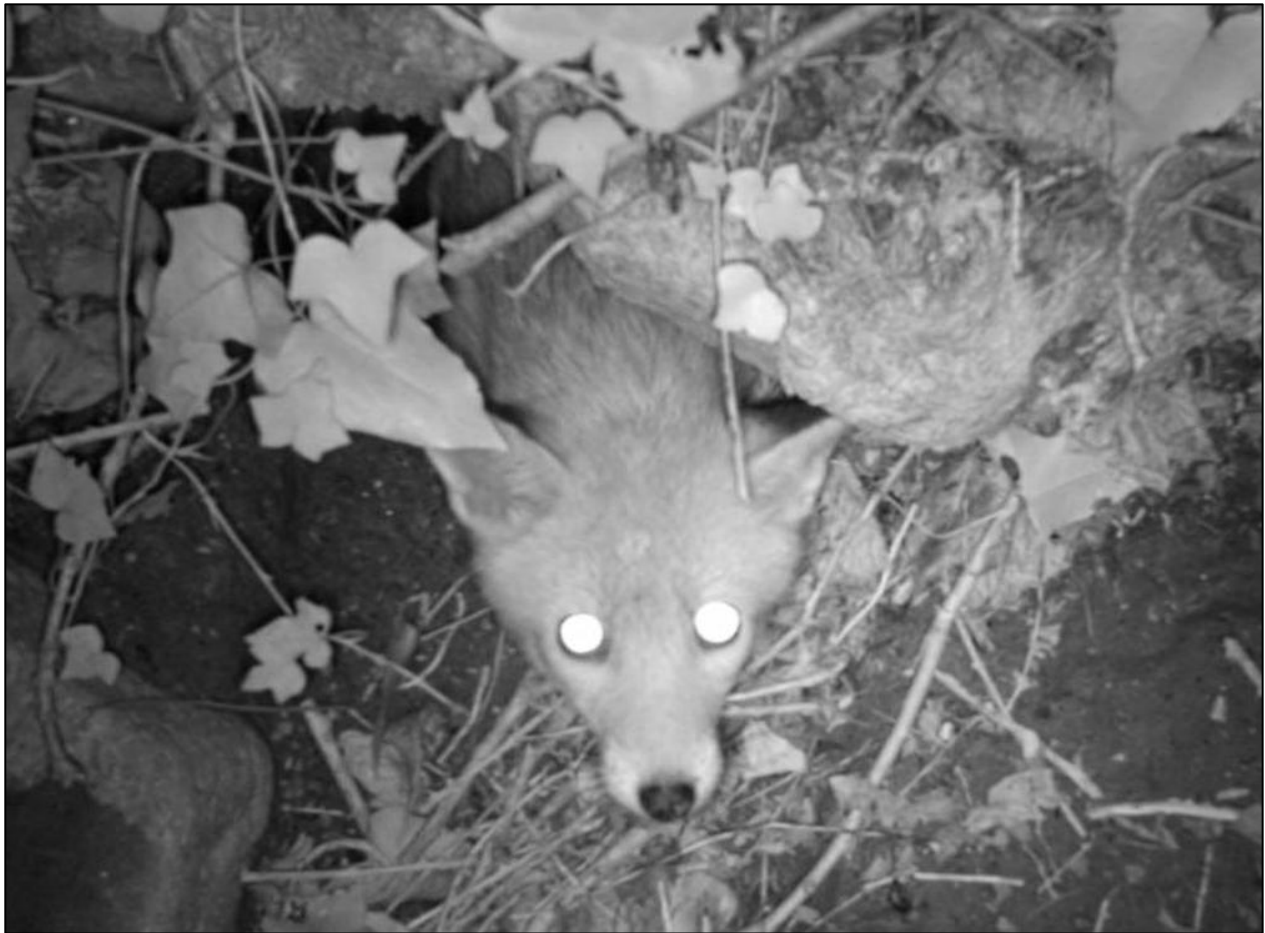
A potential single entrance holt, with two accompanying slides, was recorded along the left bank of the Shanganagh River, within Bayview Glen residential area, which is situated between the Bayview and Brookdene work areas. A sprinting site was also recorded within 15m of this potential resting site.

Monitoring of this potential holt revealed that it was currently being utilised by Red Fox on a regular basis (Figure 5-3).

Figure 5-3: Red Fox emerging from potential holt entrance at Bayview Glen (left bank)

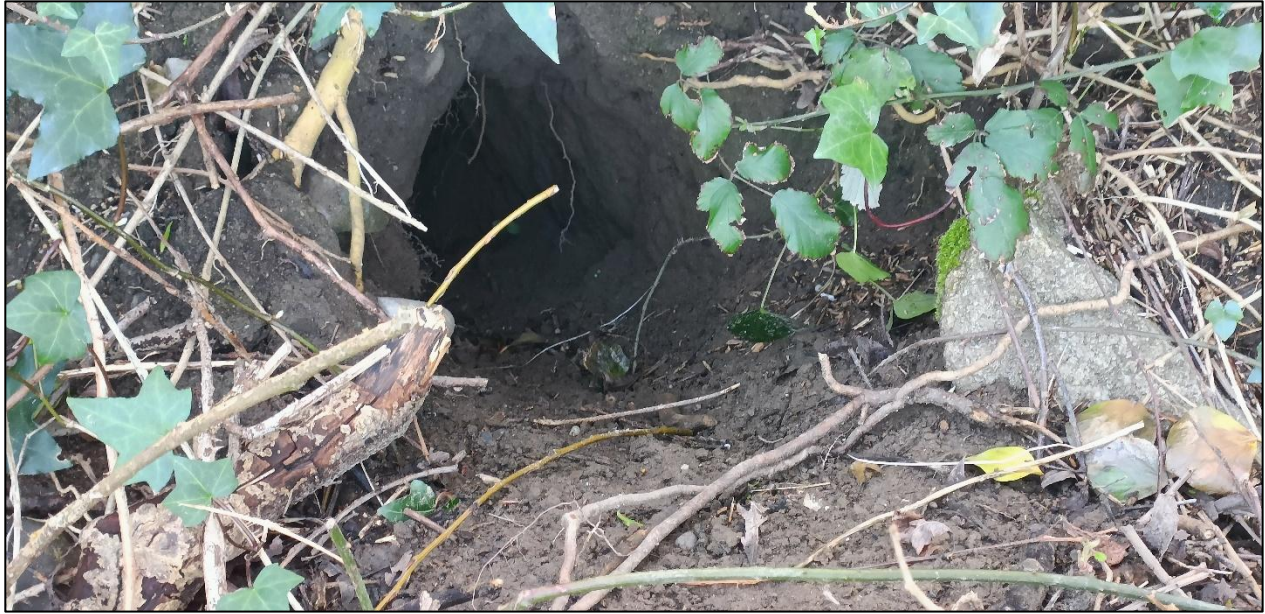
The previously identified potential Otter holt along the left bank of the Shanganagh River at Brookdene, was thoroughly examined from instream and top of bank (Figure 5-4). This potential holt has multiple entrances, seven in total, though entrance size varied notable, with only three entrances comfortably allowing entry for Otter, and one other entrance that would allow entrance, but mobility would be somewhat limited for an adult Otter. The remain three entrances were invasive European Rabbit *Oryctolagus cuniculus* -sized, though no other signs of their habitation (e.g. droppings) were present.

Monitoring of the potential holt revealed that it was occasionally being utilised by local Red Fox. This was also the case when this potential holt was monitored during the 2024 survey period.

Figure 5-4: The river-facing entrance of the potential holt at Brookdene along the left bank

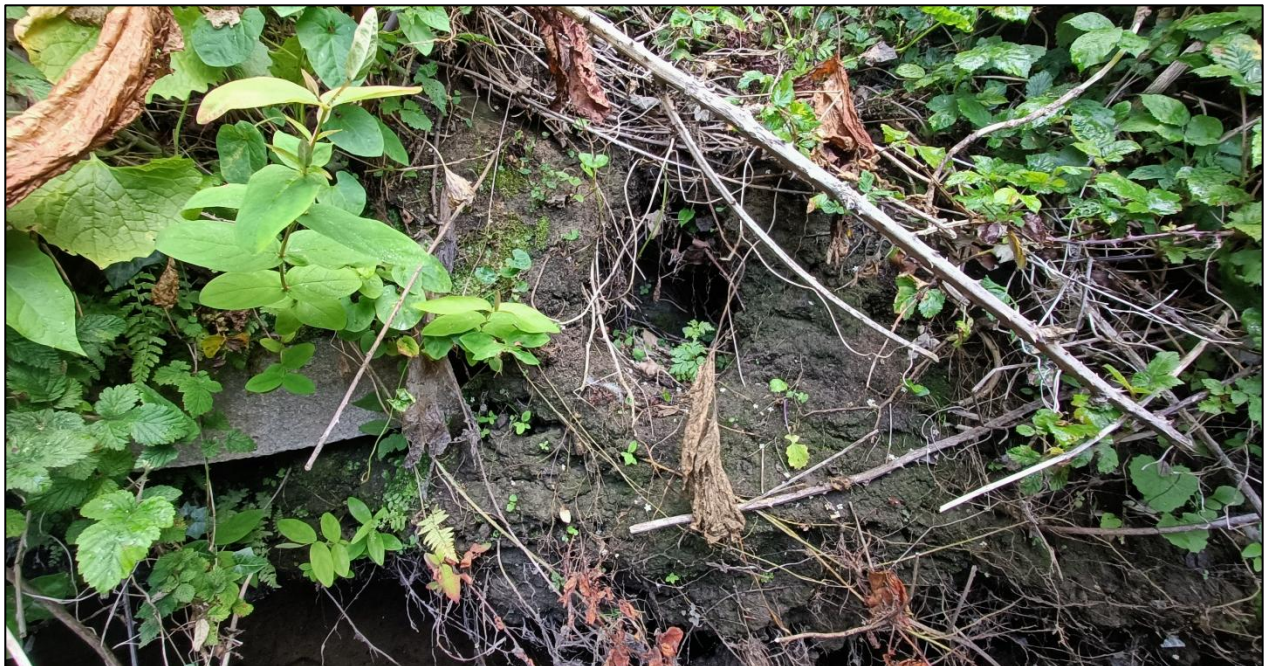
Surveyors recorded a potential abandoned Otter holt along the left bank of the Shanganagh River, approximately 30m away from the nearest works area along the Commons Road. The notable debris and vegetation growth within the single entrance suggest that this potential holt has not been used for quite some time, likely over a year given the extent of the debris/detritus and vegetation growth currently in place (Figure 5-5). For these reasons, this abandoned potential holt was not camera-trap monitored. It was also in the same condition at the end of the 2026 survey period. However, it should be noted that this will be key potential to resurvey during the pre-construction phase, as its positioning within the bank, and the physical characteristics would make it very difficult for the likes of Red Fox or Badger to utilise this burrow so the likelihood of this resting site being an Otter holt is quite high.

Figure 5-5: Potential abandoned holt on the left bank along Commons Road

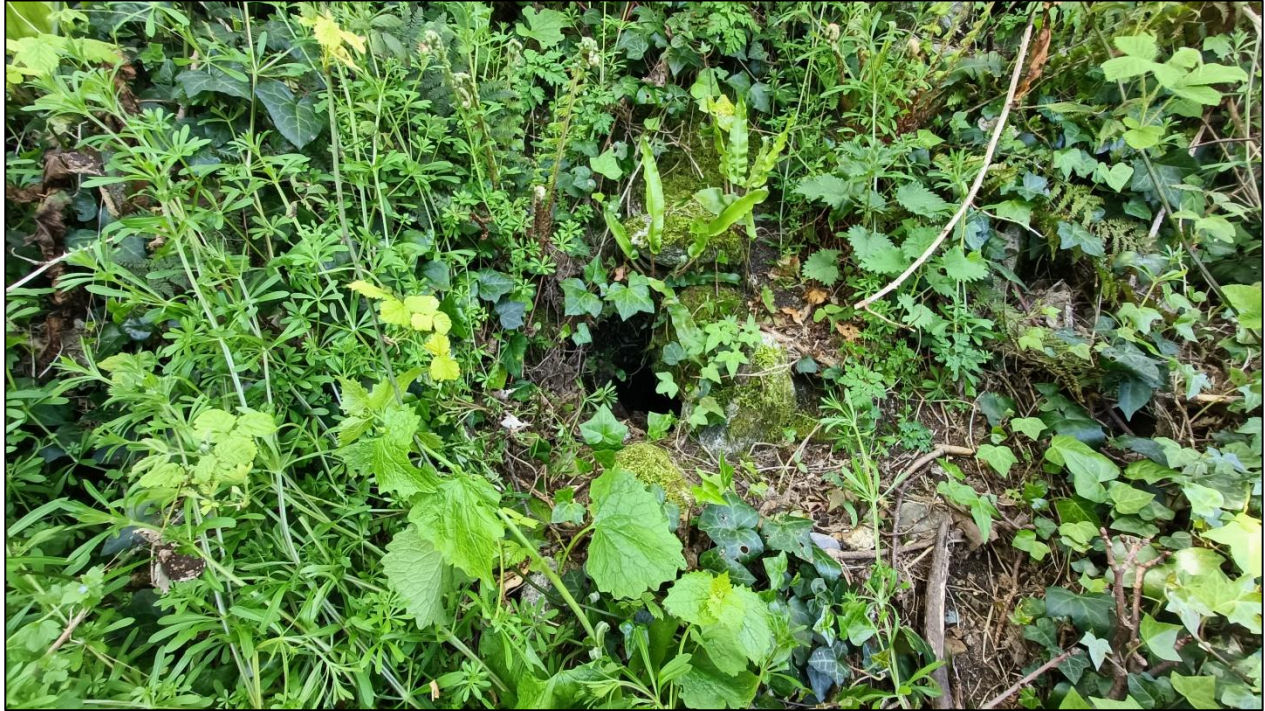
A historically active Otter holt (several years ago) was located within Loughlinstown Wood pNHA and following a condition / utilisation assessment, it was determined to be abandoned given notable detritus and vegetation growth within and around the single entrance holt (Figure 5-6). The location of this now abandoned holt is outside of the legal disturbance buffers and the 200m survey buffer outlined within further information request. Based on this rationale, this abandoned potential holt was not camera-trap monitored during the 2026 survey period.

Figure 5-6: Abandoned holt (historically active) along the right bank adjacent to the local Pitch and Putt

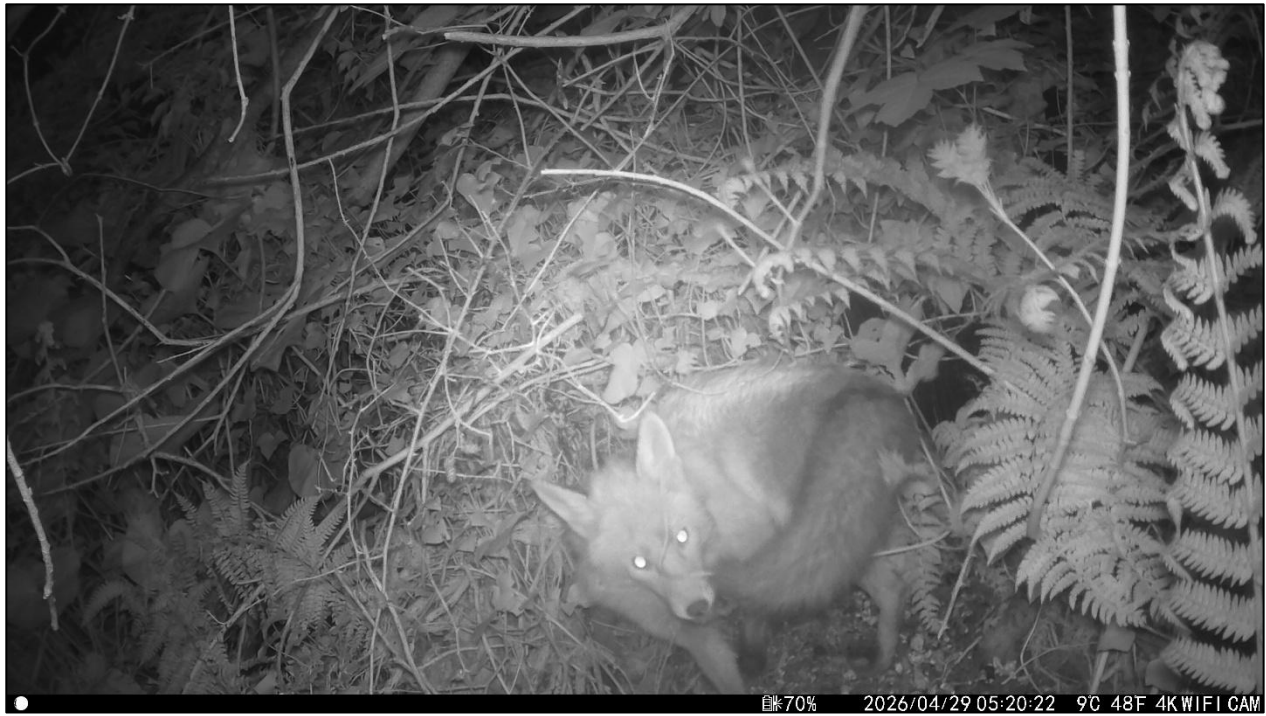
A second potential Otter holt was discovered nearby the Loughlinstown Pitch and Putt, with recent signs of excavation, meaning that it had recently utilised. Subsequent camera-trap monitoring revealed that it was currently being utilised by a pregnant (camera-trap footage revealed clearly presenting teats) female Red Fox (Figure 5-7), that was undertaking additional excavations, likely to make the internal chamber more accommodating for the birthing of upcoming litter.

Figure 5-7: A female Red Fox emerging from the potential holt north of Loughlinstown Pitch and Putt

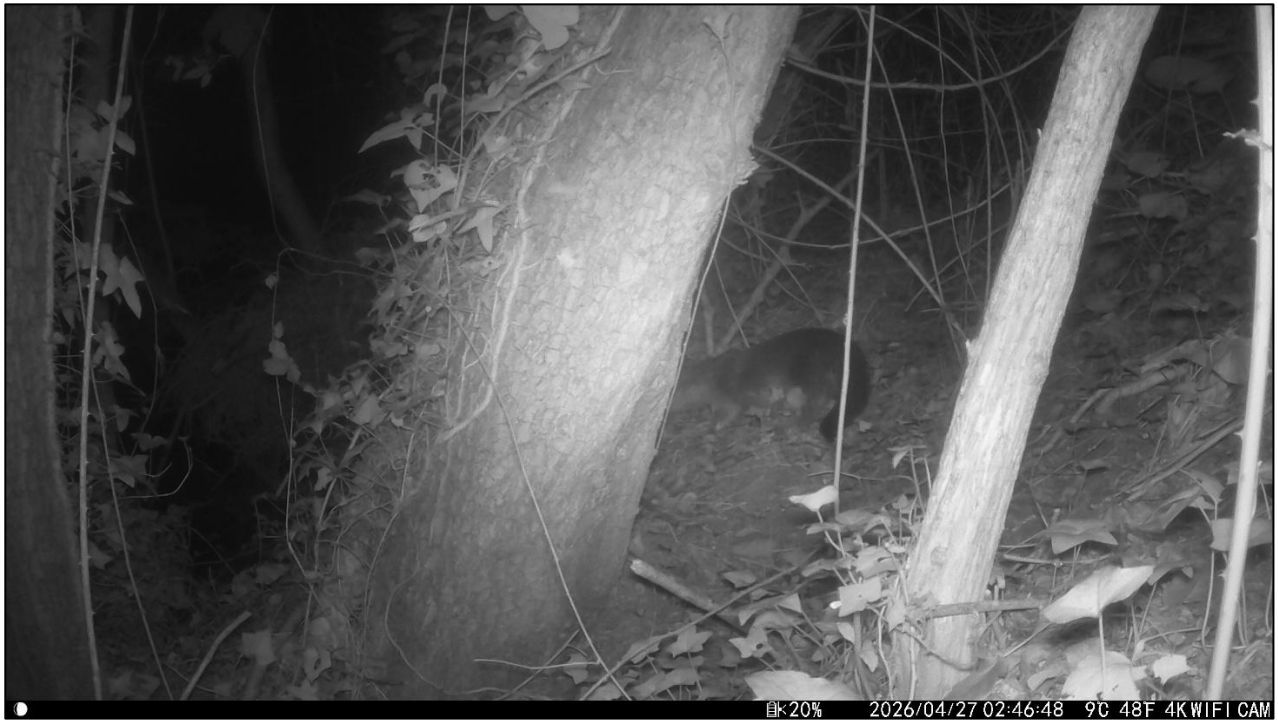
A potential holt was recorded near the Shanganagh River forming confluence of the Brides Glen Stream and Carrickmines Stream. The potential holt appeared inactive; however, as the single entrance holt was position so low on the bank, debris from the latest high flow had the ability to give a false impression of its activity status. A frequently used sprainting site was also located adjacent to this potential holt. Subsequent monitoring of this potential holt identified that an individual Otter was resting (dry coated Otter) somewhere within the locality, but not within the targeted holt (Figure 5-8). As it is possible for Otters to terrestrially navigate over the culvert outflows from the N11 into the confluence area where the camera-trap was deployed, this dry Otter could have resting within deep scrub /understorey cover on either bankside somewhere within the locality of this section of Loughlinstown Wood pNHA. Additional surveying was undertaken in May 2026, but vegetation growth of the woodland's understorey made it very difficult identify and potential densely covered couch within the locality.

Figure 5-8: A dry Otter (no reflection for moisture in coat and fuzzy outline) entering the water adjacent to the inactive holt at the confluence east of the N11

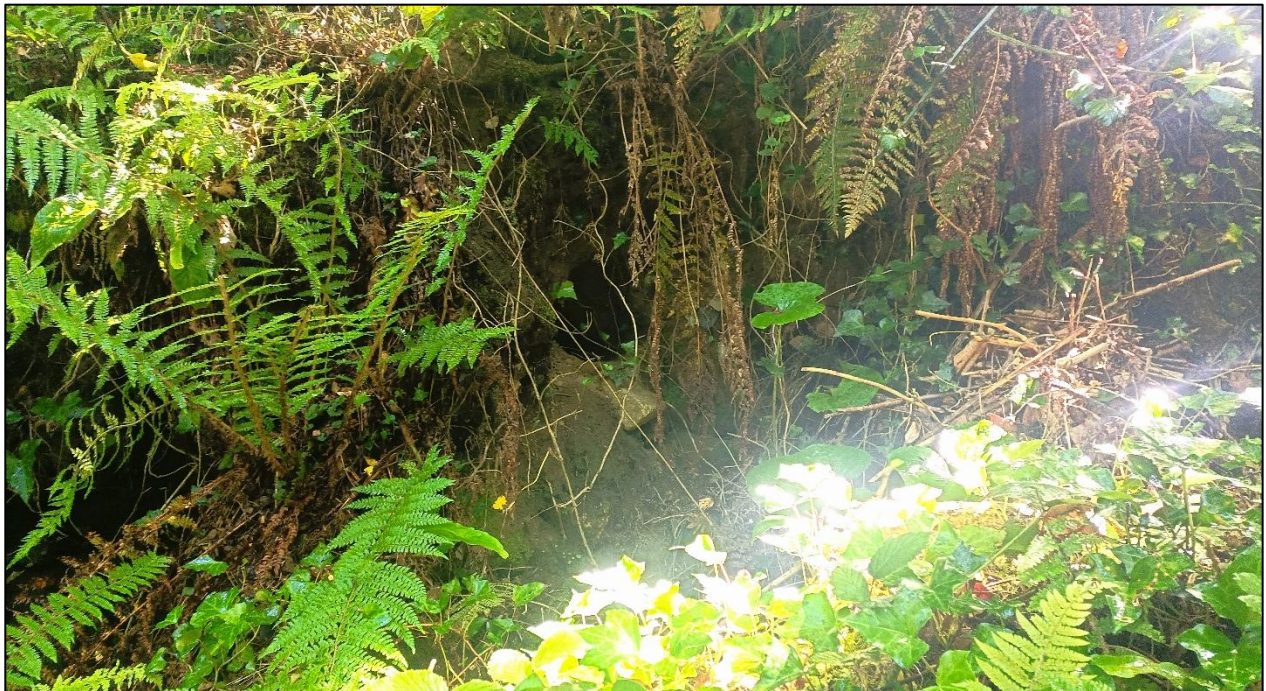
Surveying upstream of the Cherrywood Road works site, along the Brides Glen Stream, identified a potential holt along the right bank of the stream, along with two accompanying slides down from lower bank shelf containing the two-entrance resting site (Figure 5-9). The main entrance as displayed in the below photo, had shown signs of recent use, i.e., within the spring period. Camera-trap monitoring of the potential holt failed to capture its use by any of the local non-volant mammals.

Figure 5-9: Potential holt on the right bank of the Brides Glen Stream, upstream of Cherrywood Road

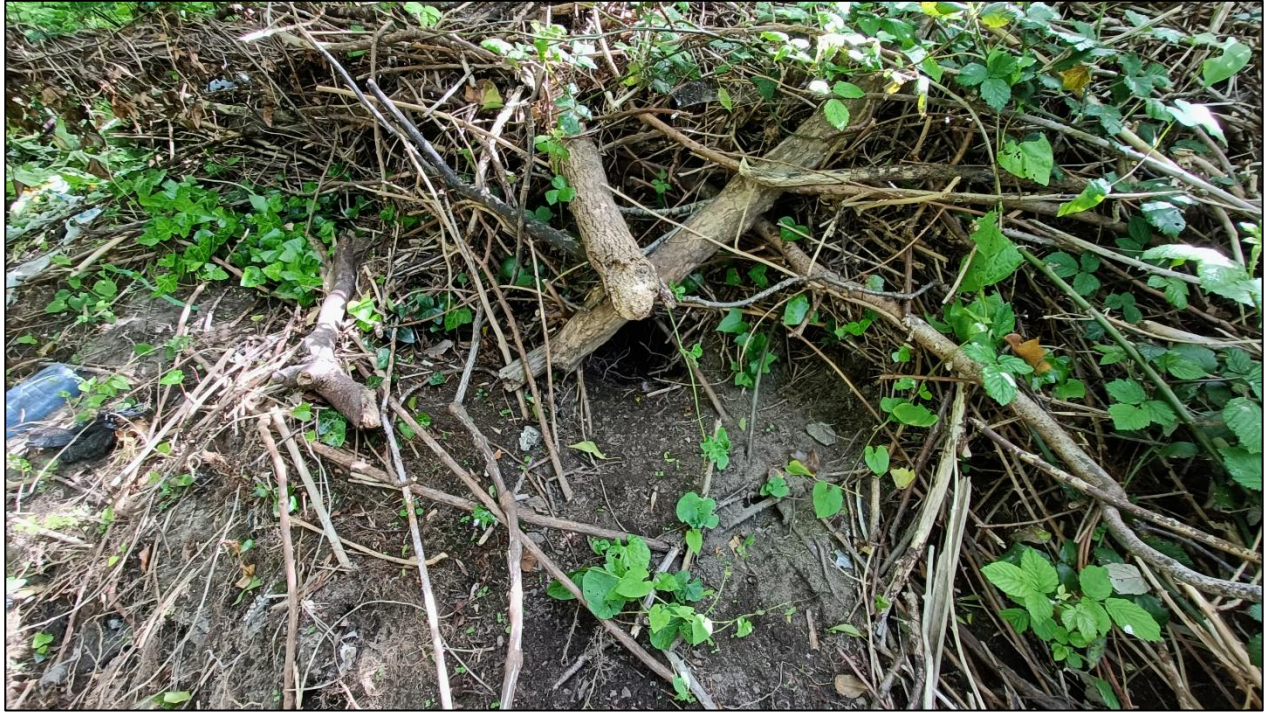
Surveyors noted a depression in the earth under a pile of branches, i.e., potential couch, along the right bank of Shanganagh River near the Bayview Glen residential area (Figure 5-10). This potential Otter couch was then monitored, with the subsequent camera-trap data failing to capture any local mammals utilising this resting spot. Only Red Fox were noted commuting by this location.

Figure 5-10: Potential couch along the right bank of near Bayview Glen residential area

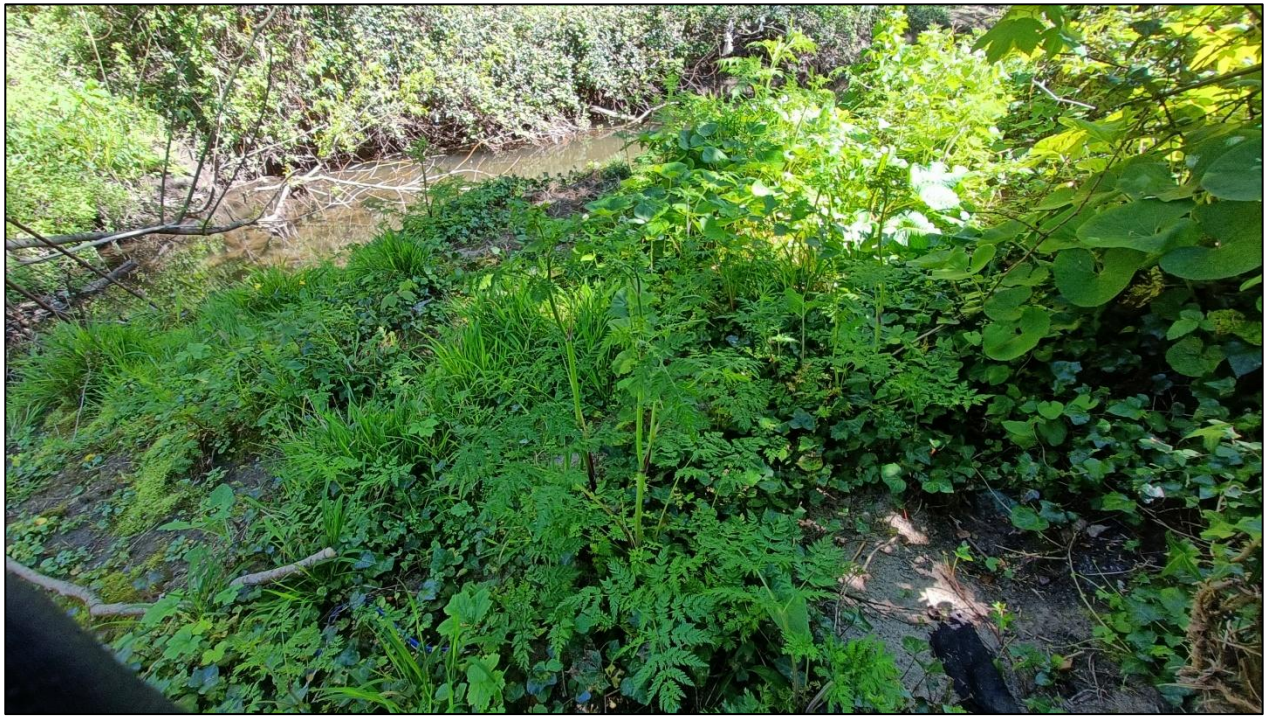
Surveyors identified a potential couch adjacent to the Loughlinstown Pitch and Putt, along the Shanganagh River (Figure 5-11). This potential couch had two slides and one sprainting site within close proximity to it, along the right bank. The camera-trap monitoring did not detect any mammals resting within the sandy oval patch amongst the vegetation (bottom right of the below photo). Local Otter were also no capture utilising the nearby sprainting site. It is important to note that monitoring at this particular potential resting site was compromised by active Giant Hogweed *Heracleum mantegazzianum* treatments taking place concurrently. A Giant Hogweed specimen adjacent to the potential couch was sprayed early within the monitoring period; with this act likely leaving behind intrusive and unattractive scents for Otter, which may have acted as a temporary deterrent to the utilisation of this potential couch.

Figure 5-11: Potential couch on right bank of the Shanganagh River adjacent to the Pitch and Putt

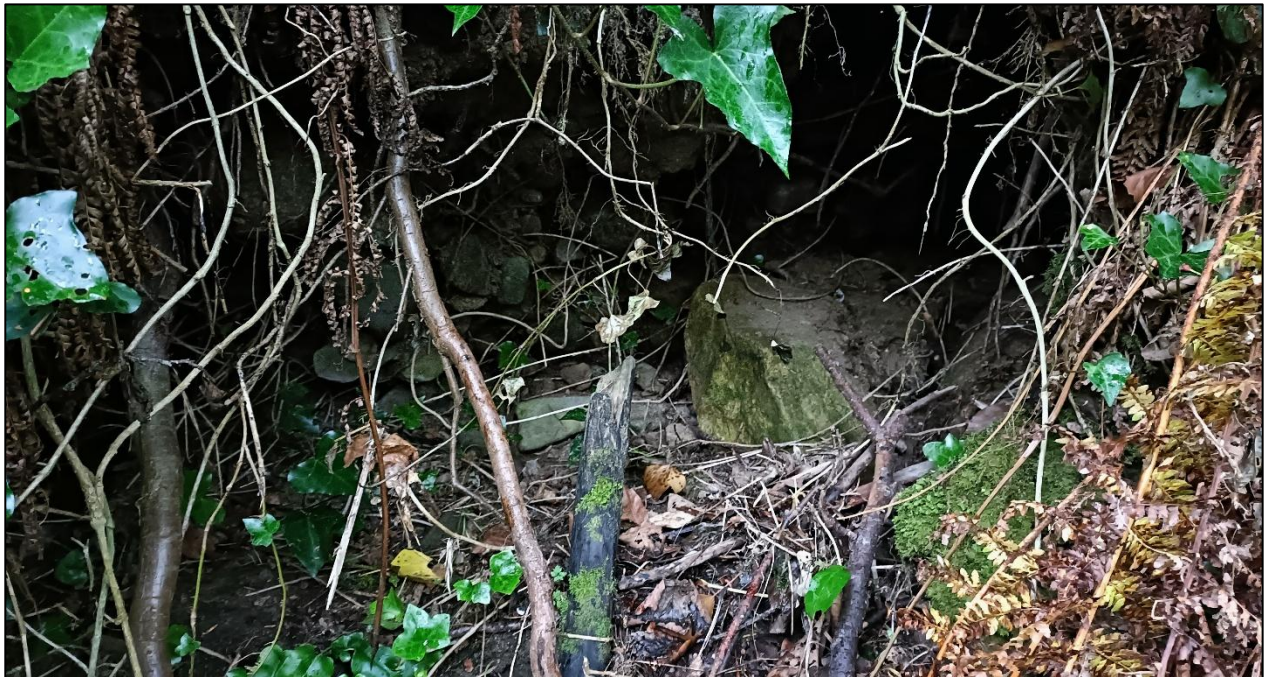
Upstream of the Cherrywood Road works site, along the Brides Glen Stream, surveyors identified a potential couch along the right bank of the stream, amongst the remains of fallen tree trunk base (

Figure 5-12). Absence of vegetation and detritus within an appropriately sized earth depression indicated that a small to medium sized mammal was resting within this space. Subsequent camera-trap monitoring of this potential couch revealed that it was currently being utilised by Red Fox.

Figure 5-12: Potential couch on the right bank of the Brides Glen Stream, upstream of Cherrywood Road

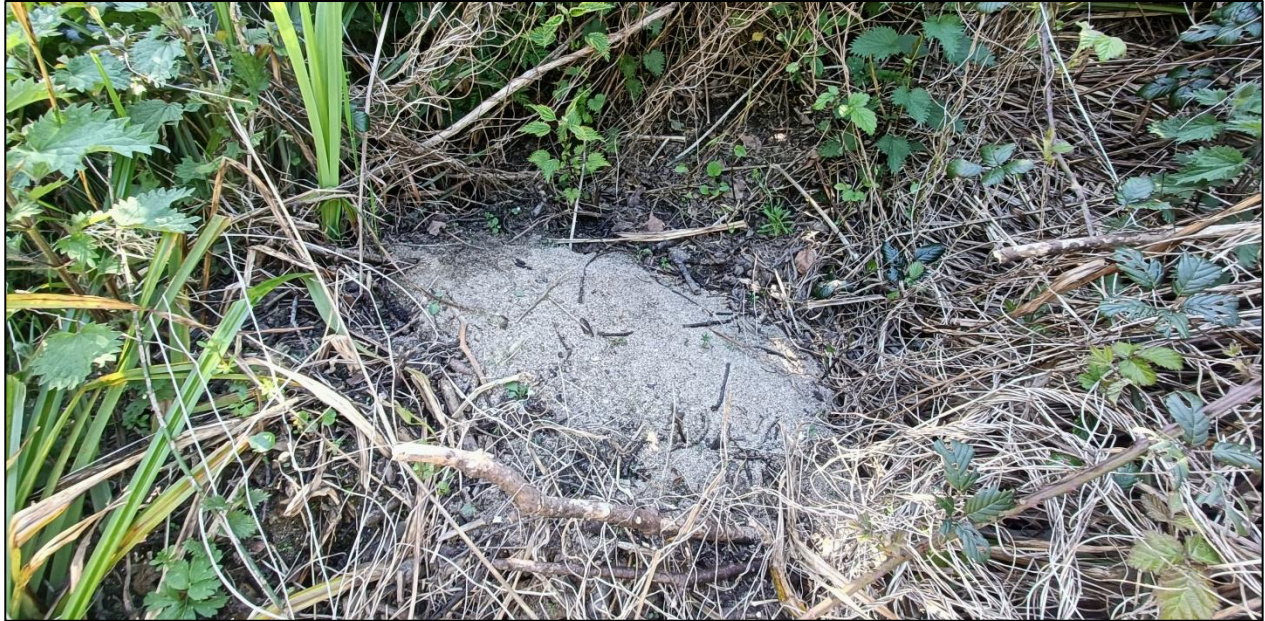
A depression of vegetation along the right bank of the Carrickmines Stream (Figure 5-13) indicated that the spot was being utilised as a couch by local Otter, the likelihood of which was increased given the presence of a frequently utilised sprainting site 10m upstream of this location. Monitoring of this potential Otter couch revealed that it was currently being utilised as nesting material collection spot for local birds, as well as a resting spot for local domestic cats.

Figure 5-13: Potential couch on right bank of the Carrickmines Stream, upstream of Bray Road works

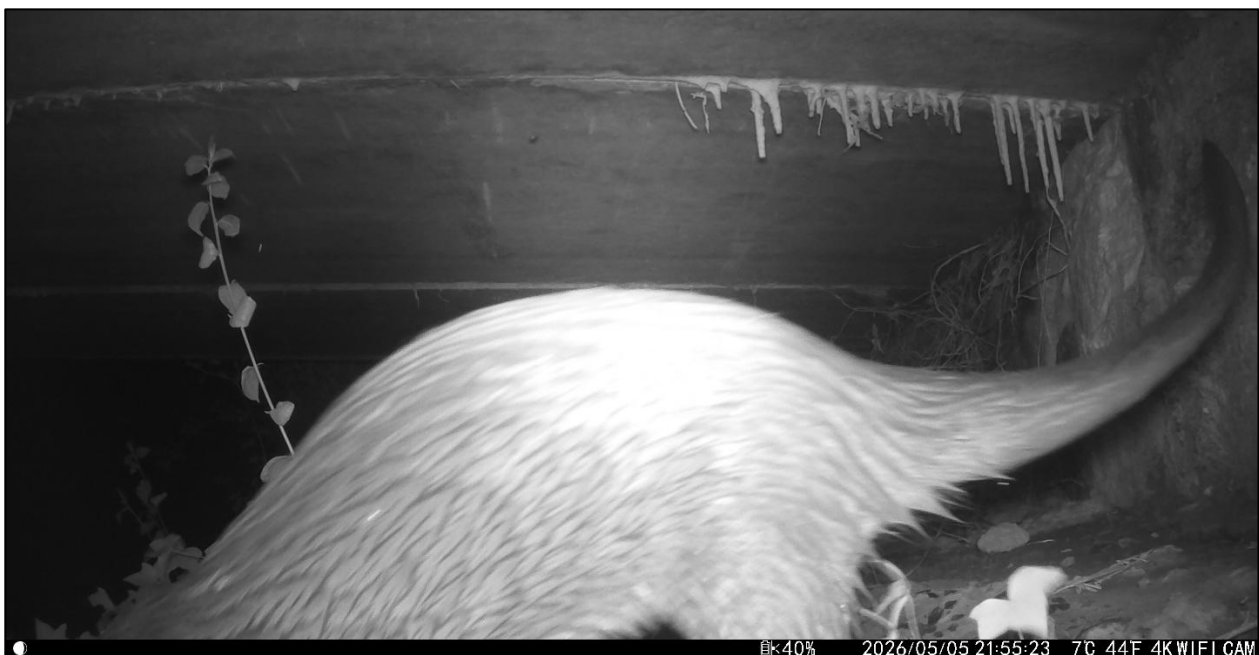
Approximately 10m further upstream, potential couch and confirmed sprainting site was also monitored, the raised bank under the pedestrian bridge displayed depression resembling resting depressions in the earth and designated sprainting points. During the monitoring of this potential resting site, only Otter spraint activity was observed (

Figure 5-14: Potential couch (and confirmed active sprainting site) upstream of the Bray Road site

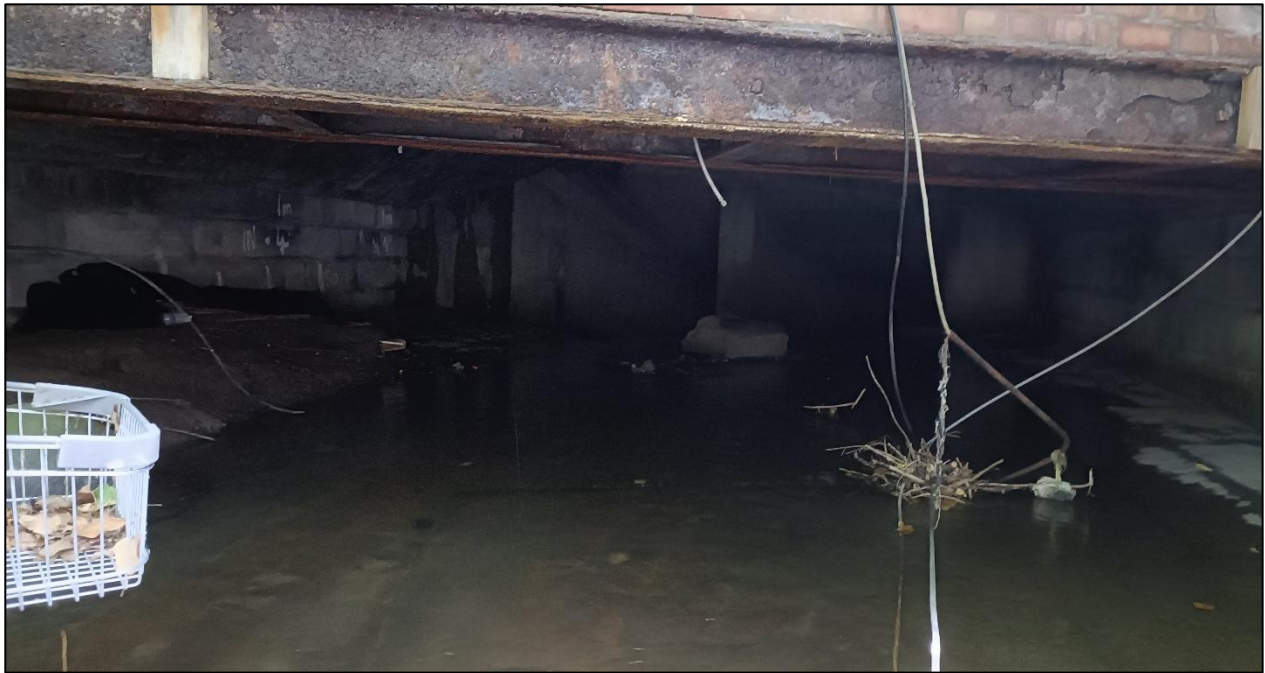
The most notable hard commuting barrier is the Carrickmines Stream's culverted section under the N11. The bend in the culvert, impacting lightening throughout its length, the anthropogenic disturbances (present within the left background of Figure 5-15), and lack of mammal ledge make this culverted section sub-optimal for Otter commuting activity. However, despite these sub-optimal conditions, Otter regularly frequent either end of this culverted section with a sprainting site adjacent to the eastern end of the culvert, and a sprainting site within sediment build-up at mouth of the culvert on the western inflow. Furthermore, the Otter that consume the Ballan Wrasse, deposited the spraints containing the marine fish, either side of this culverted section so it is evidently not a potential territorial boundary / barrier for the local Otter population.

Figure 5-15: Carrickmines Stream N11 culvert displaying anthropogenic disturbance and sub-optimal Otter commuting

The newly proposed 2.4m diameter overflow culvert to be installed under the N11 at the Lower Brides Glen work area, will provide safe, spacious and dry passage for Otter and other non-volant mammals during low flow conditions within the Brides Glen Stream. This passage will become wetted as water levels raise and the stream flows over the new overflow weir along its left bank, which directs these flows towards the new culvert. Otter, other non-volant mammals, birds and amphibians will be able to navigate this spacious underpass in most frequent low level flood events; however, when extreme flood events occur, i.e., 1% AEP / 1–100-year flood event, only Otter will be able to navigate through this culvert underpass. It is also important to note that the vast majority of other vertebrate fauna will instinctually seek cover in elevated habitats, e.g., upper banks of Shanganagh River within the Loughlinstown Wood pNHA, rather than navigate core riparian zones in extreme storm / precipitation events.

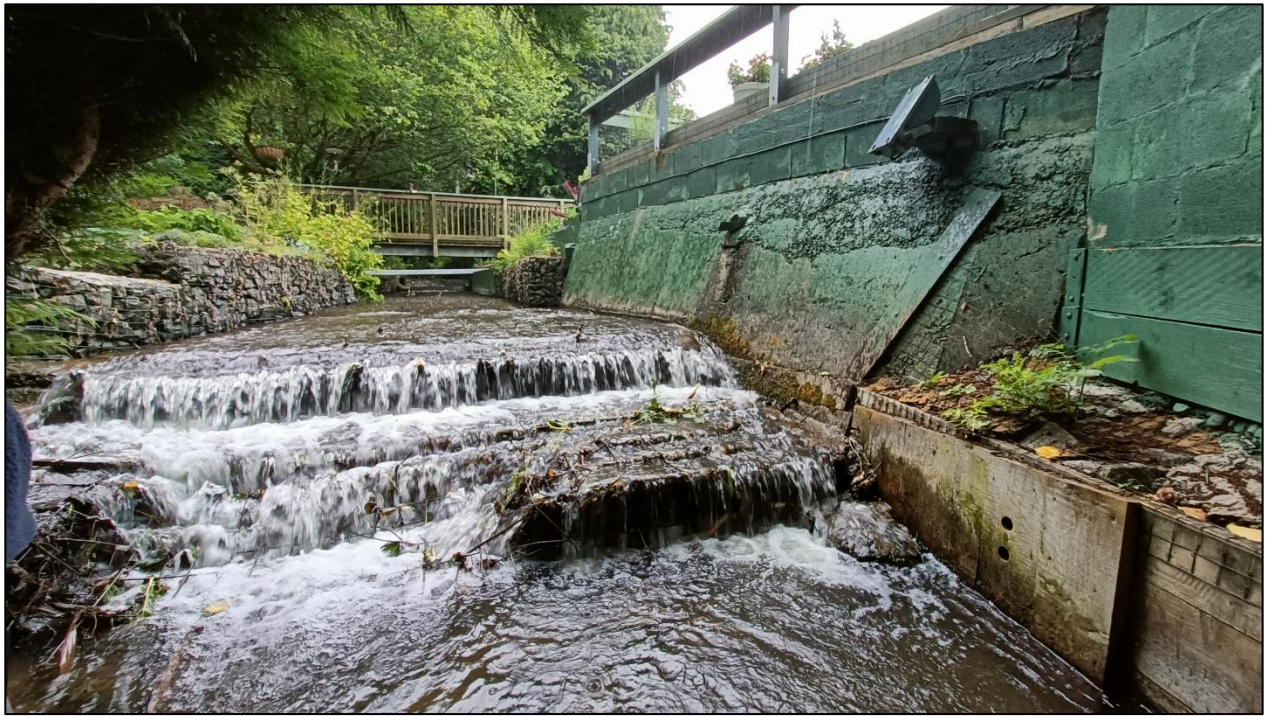
Two fish migration barriers (weirs) are present within and downstream of the proposed scheme's work areas. These weirs have been confirmed as fish migration barriers by Inland Fisheries Ireland following assessment. One of the weirs is located along Commons Road, just downstream of the Pitch and Putt course; while the other weir (Figure 5-16) is located within private land holdings along the Brides Glen Stream, between the Cherrywood Road and Lower Brides Glen work areas.

Figure 5-16: IFI-confirmed fish migration barrier along the Brides Glen Stream along Cherrywood Road
