# Carrickmines-Shanganagh River Flood Relief Scheme

## Otter Conservation Plan

Final Report

August 2026

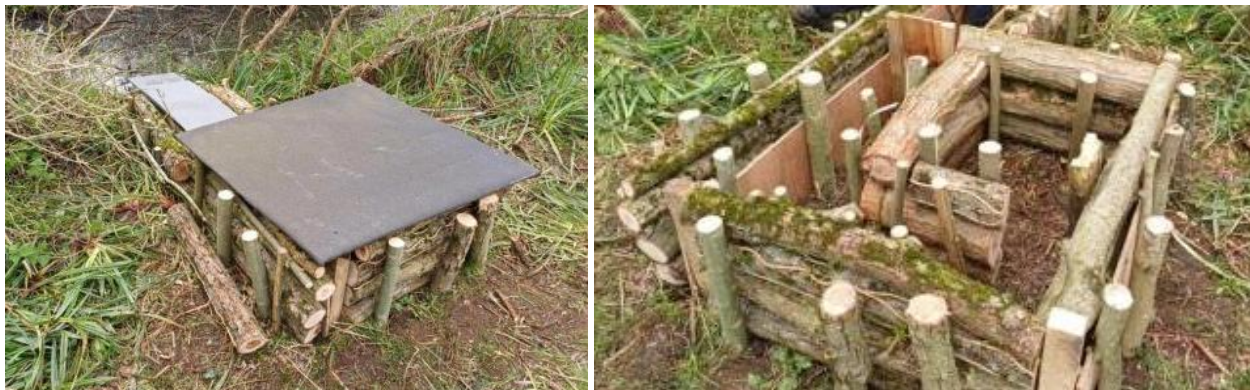
A natural material, above-ground holt design is reasonably cheap and easier to build, with little impact on the surrounding flora and soil structure within the riparian zone. These artificial holts are being referred to as short-term resting sites as they only last several years before the woods rot and the structural integrity and thermal insulation capacity beings to fail, leading to the local Otters abandoning them for higher quality shelters. An example of this natural artificial holt design is shown below in Figure 7-1.

Figure 7-1: Natural materials artificial Otter holt design (©Oxford Preservation Trust)
