# Carrickmines-Shanganagh River Flood Relief Scheme

## Bat Roost & Activity Assessment

Final Report

August 2026

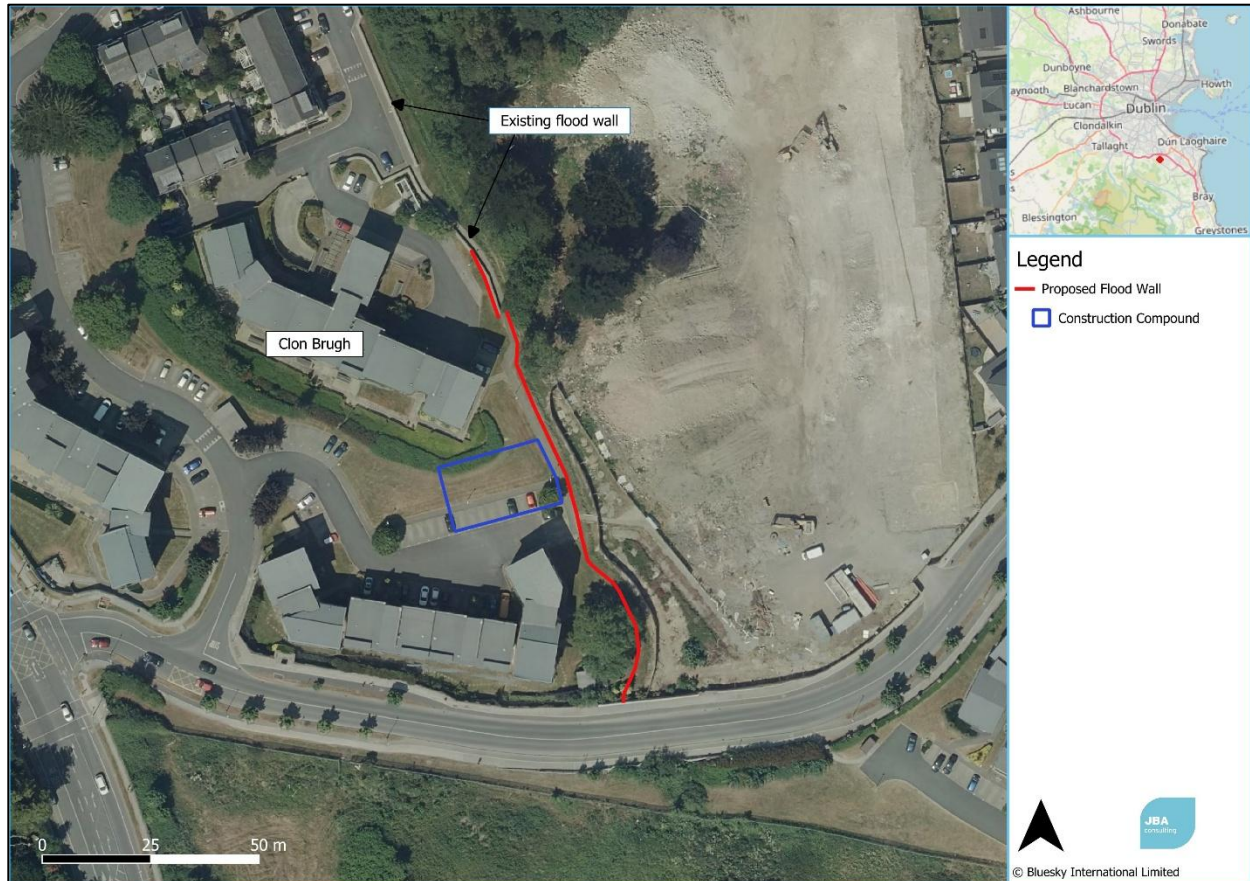
**Figure 2-2: Clon Brugh Site Location**

Clon Brugh (Figure 2-2) is a residential estate situated just east of the R117 Enniskerry Road. It comprises a mix of 3-4 storey apartment blocks and houses, with small green areas, car parking, and footpaths. The proposed works in this area will be located along an area of linear green space and footpath. The area surrounding Clon Brugh is also primarily residential, with green space to the west and south in the Dublin mountains foothills.

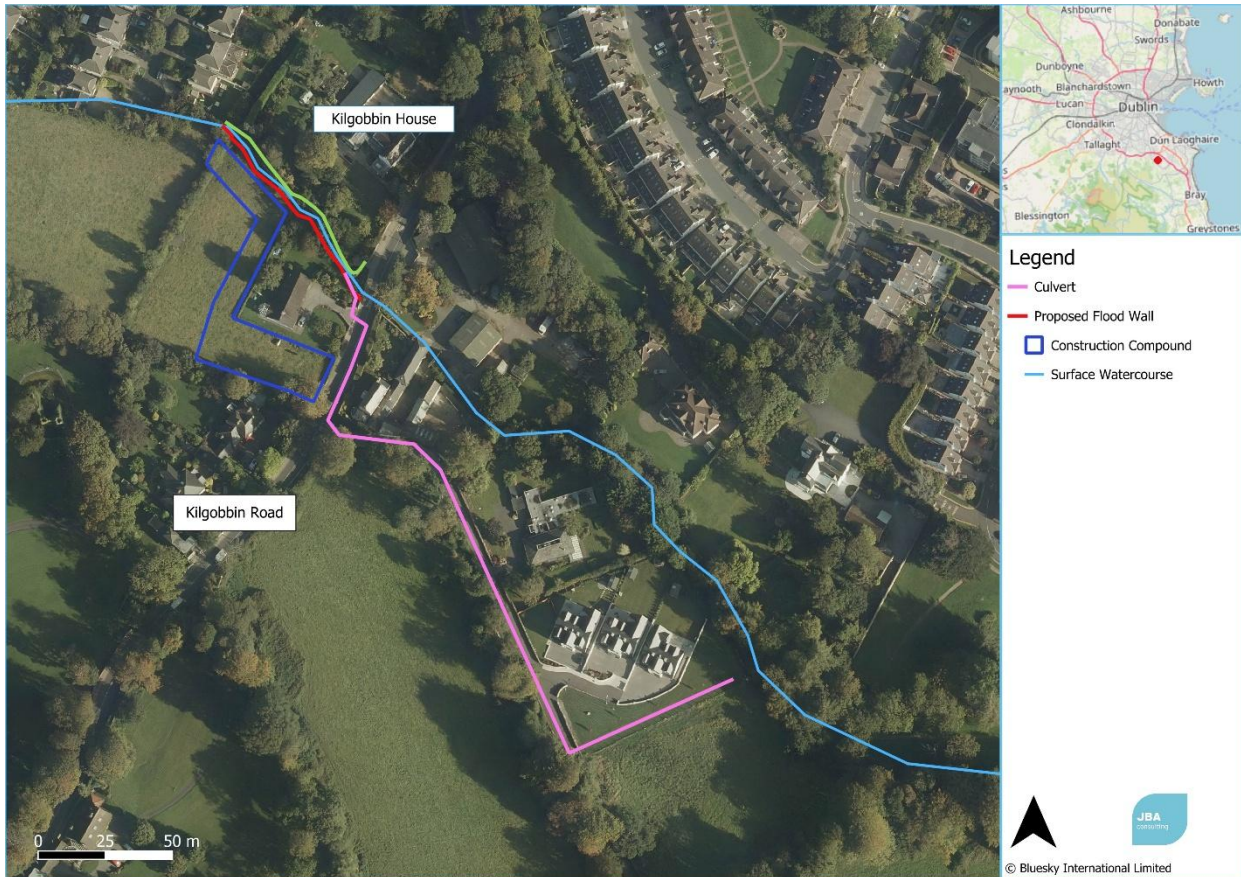
**Figure 2-4: Kilgobbin Road Site Location**

Kilgobbin Road (Figure 2-4) is a small road lined with trees and stone walls, with a narrow footpath on one side for much of its length. The works in this area will take place along the boundaries of two houses on the western side of the road, before running beneath the road and turning east down a narrow laneway, finally running across an area of open space to join back with the river approx. 220m downstream. The houses in this area are all detached, on large plots of land. Kilgobbin House is a protected structure (RPS No.1684) whose stone wall boundary will be removed and reconstructed as a flood wall.

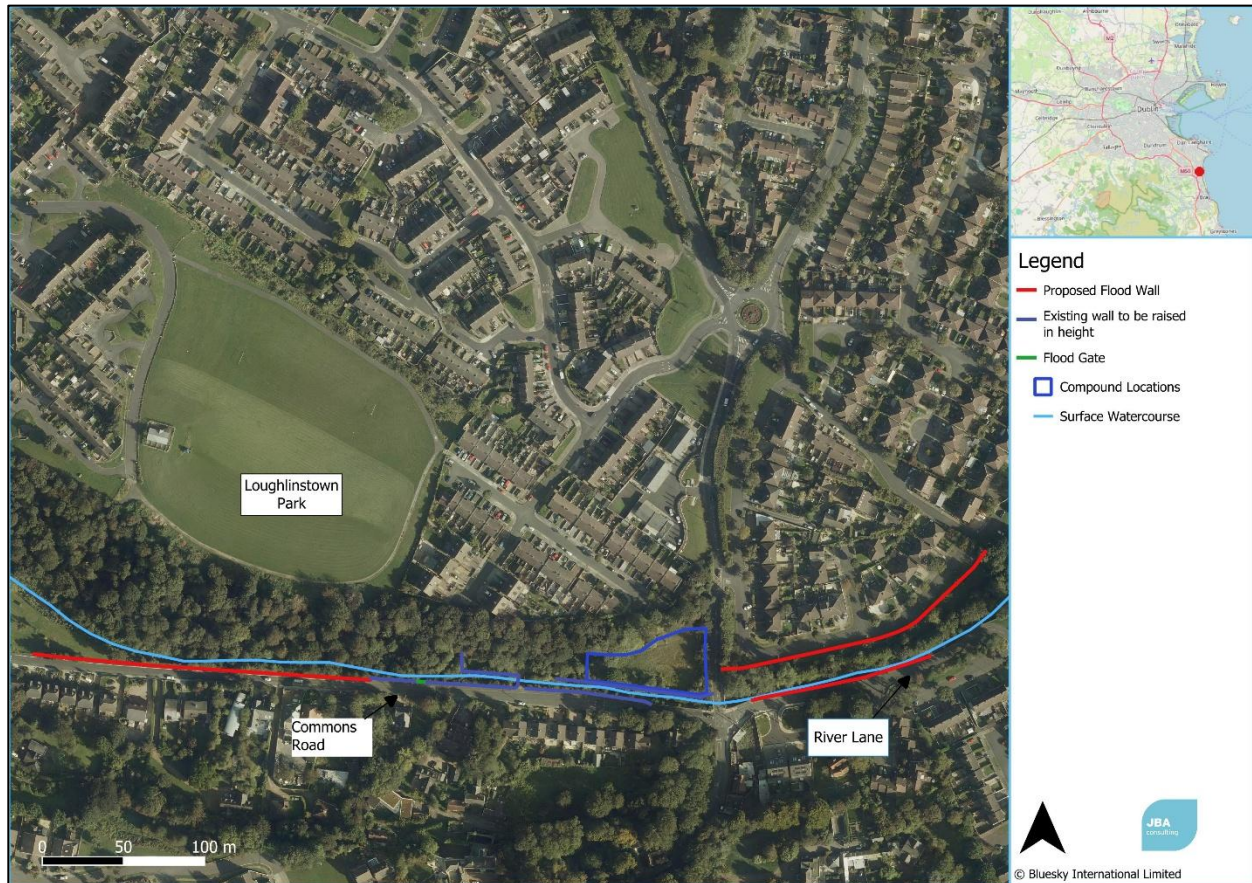
**Figure 2-8: Commons Road, River Lane and Brookdene Site Location**

Works at the Commons Road, River Lane and Brookdene Site Location (Figure 2-8) will take place along the Shanganagh River as it flows from west to east along Commons Road, under the Shanganagh Road Bridge, and between River Lane and Brookdene. Upstream of the bridge, Commons Road has residential development along its south side, with the river adjacent to the north. The northern side of the river at this point is wooded, with one house and a bridge providing access at roughly the midway point of the works. North of the wooded area is housing. Shanganagh Road Bridge is a protected structure (RPS No. 1772) and is a narrow two-lane stone arch bridge. Downstream of the bridge, River Lane and Brookdene are both residential roads, with a footpath adjacent to the river along River Lane, and a riparian strip and tree line on the left (north) bank at Brookdene.

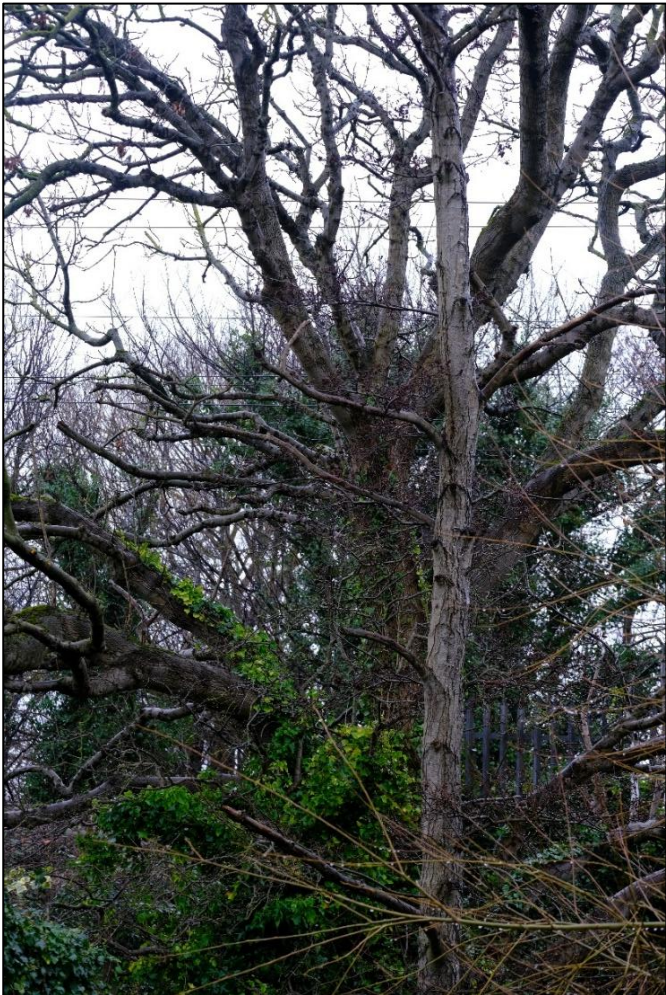
| Tree No. & Location | Bat Roost Potential | Notes | Photos |
|---|---|---|---|
| 1821 | No features rated above Negligible suitability for roosting | <p>Mature Ash in rear</p> <p>Mature Ash – healthy</p> <p>No large wounds or fissures present</p> <p>Sparse, young ivy</p> | |

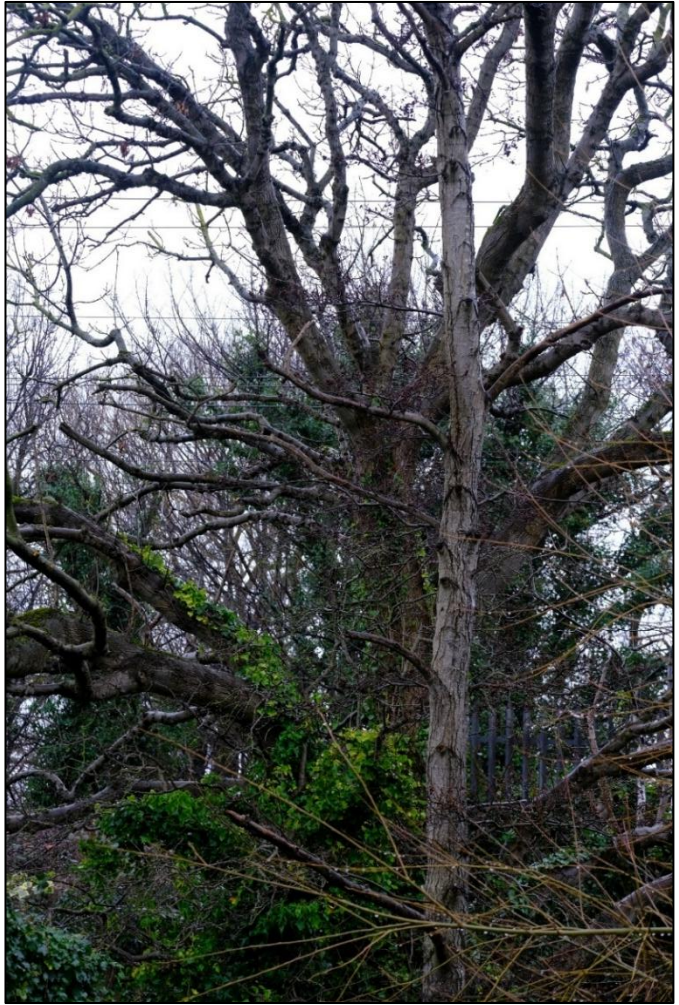
| Tree No. & Location | Bat Roost Potential | Notes | Photos |
|---|---|---|---|
| 1822 | No features rated above Negligible suitability for roosting | Alder in foreground | |

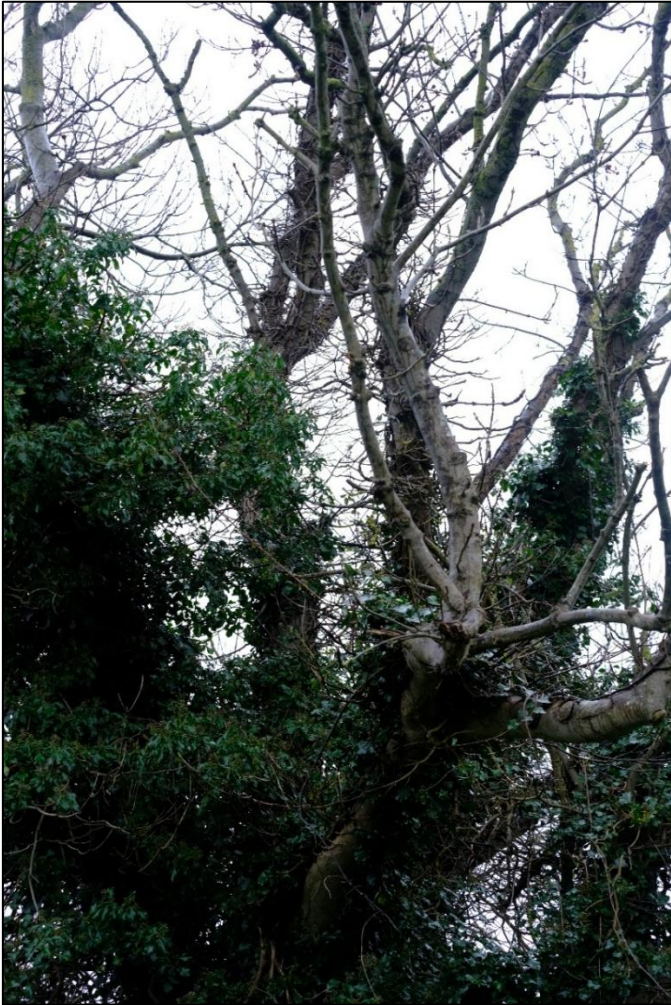
| Tree No. & Location | Bat Roost Potential | Notes | Photos |
|---|---|---|---|
| 1823 | No features rated above Negligible suitability for roosting | <p>Mature Ash – in decline</p> <p>Ivy cover – some semi-mature Ivy, mainly on main trunk. No suitable pockets formed for roosting.</p> <p>Small fissures present, but with no notable depth for insulated roosting</p> <p>Bird nests present in fork</p> | |

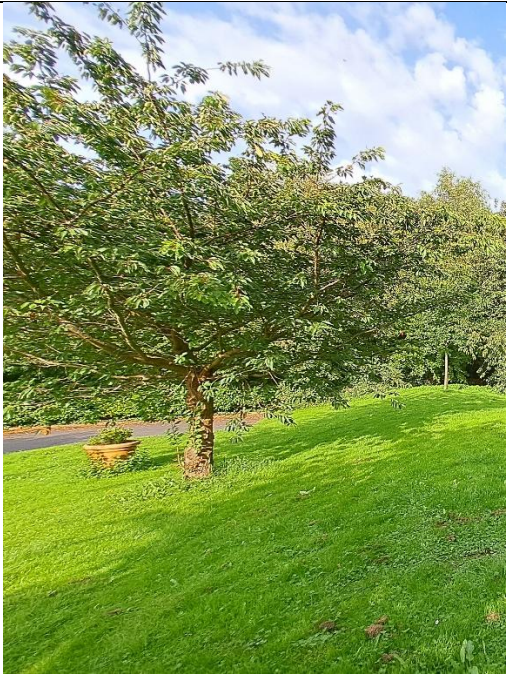
| Tree No. & Location | Bat Roost Potential | Notes | Photos |
|---|---|---|---|
| 1831 – 1832 x9 (northern most two trees) | No features rated above Negligible suitability for roosting | Semi- mature Cherry with shallow peeling bark / fractured bark, as is standard with Cherry trees. | |

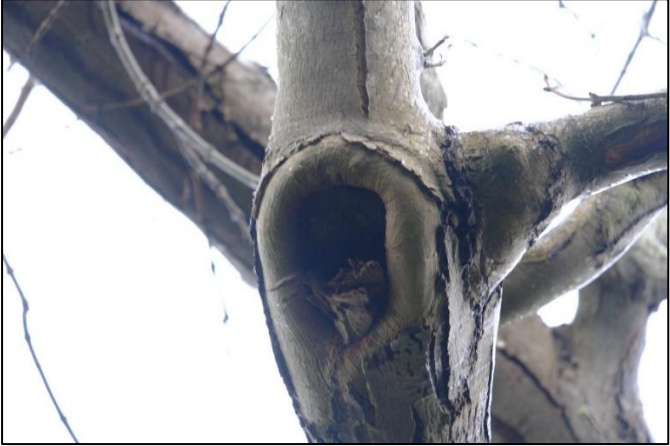
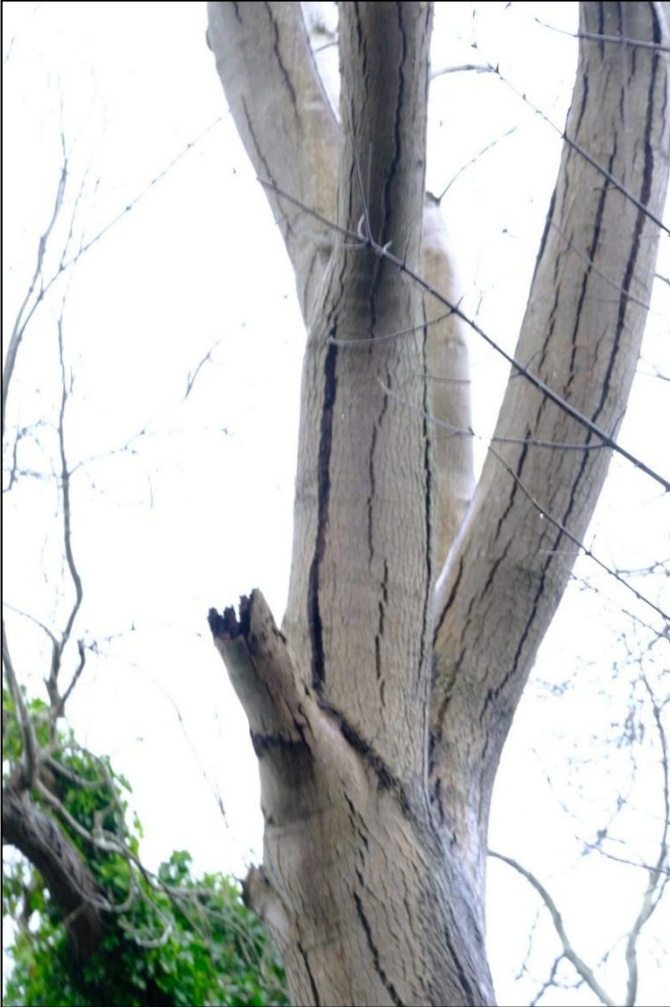
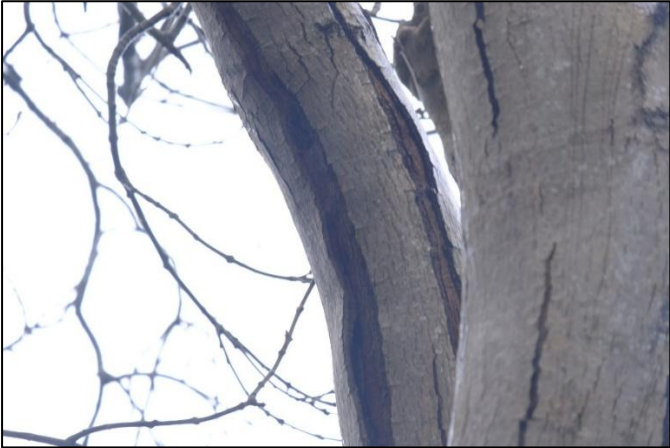
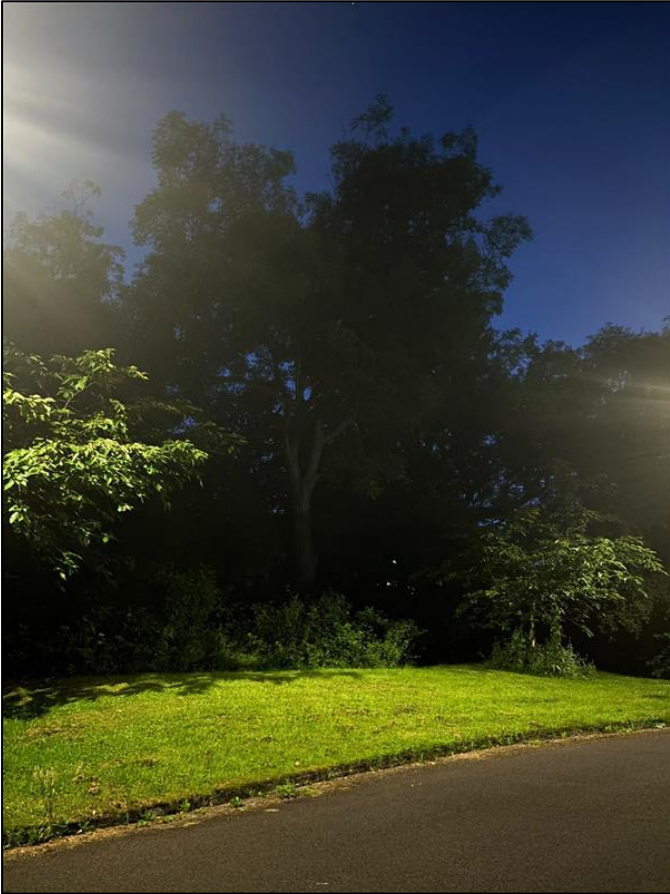
| Tree No. & Location | Bat Roost Potential | Notes | Photos |
|---|---|---|---|
| 1830 | Moderate potential – however due to light spillage from neighbouring lampposts, the tree is considered to have Low potential for bat roosting | <p>Mature Ash – sub-optimal condition</p> <p>A number of wounds are present with a significant presence of fissures, which are mostly shallow.</p> <p>One fissure is suitable for summer roosting.</p> <p>More fissures and peeling bark are present higher up the tree, although no deep hollows are present. Small holes are present on tree although these have limited suitability for bats. Later during the summer bat surveys, the tree had developed further developed</p> | |

| Tree No. & Location | Bat Roost Potential | Notes | Photos |
|---|---|---|---|
| | | <p>existing fissures which had low-moderate bat roosting potential.</p> <p>However, this tree has is impacted by light spillover from surrounding street lighting, making it unsuitable for roosting bats.</p> | <p>Example of hole present on mature Ash</p> |

| Tree No. & Location | Bat Roost Potential | Notes | Photos |
|---|---|---|---|
| | | | <p data-bbox="750 275 1412 302">Example of fissures and peeling on trunk of mature Ash</p> <p data-bbox="750 822 1305 848">Fissure with summer roosting potential for bats</p> <p data-bbox="750 1818 1426 1881">Light pollution trunk and main limbs from two neighbouring lampposts</p> |

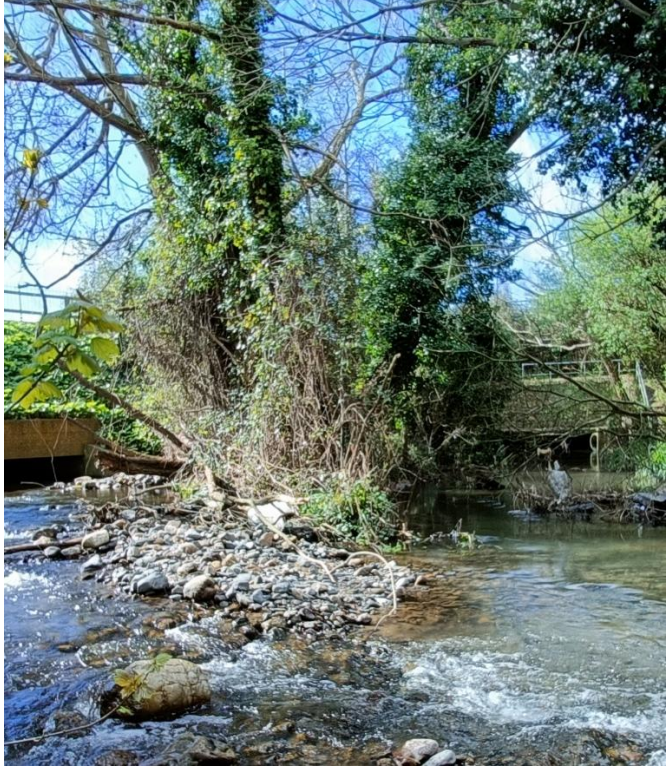
| Tree No. & Location | Bat Roost Potential | Notes | Photos |
|---|---|---|---|
| T10 | No features rated above Negligible suitability for roosting | <p>Cluster of mature Ash and Willow</p> <p>Young ivy coverage present amongst cluster</p> <p>Small wounds and slight peeling though none pronounced enough to accommodate insulated roosting</p> | |

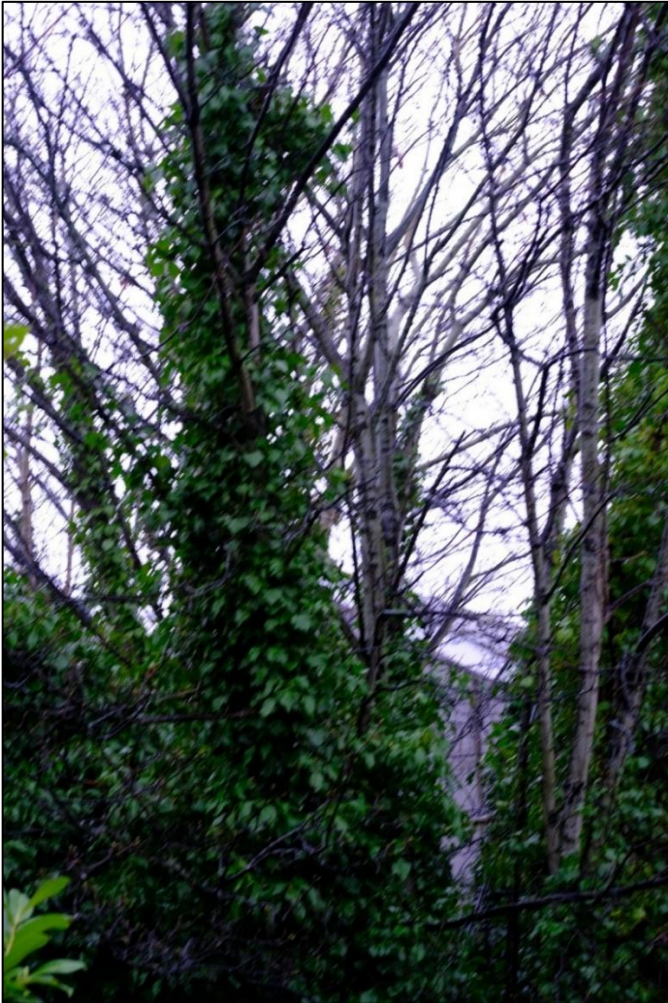
| Tree No. & Location | Bat Roost Potential | Notes | Photos |
|---|---|---|---|
| T8 | No features rated above Negligible suitability for roosting | <p>Cluster of 4 early mature Sycamore – good condition</p> <p>Ivy is present and widespread, mostly semi-mature.</p> <p>No fissures are present</p> | |

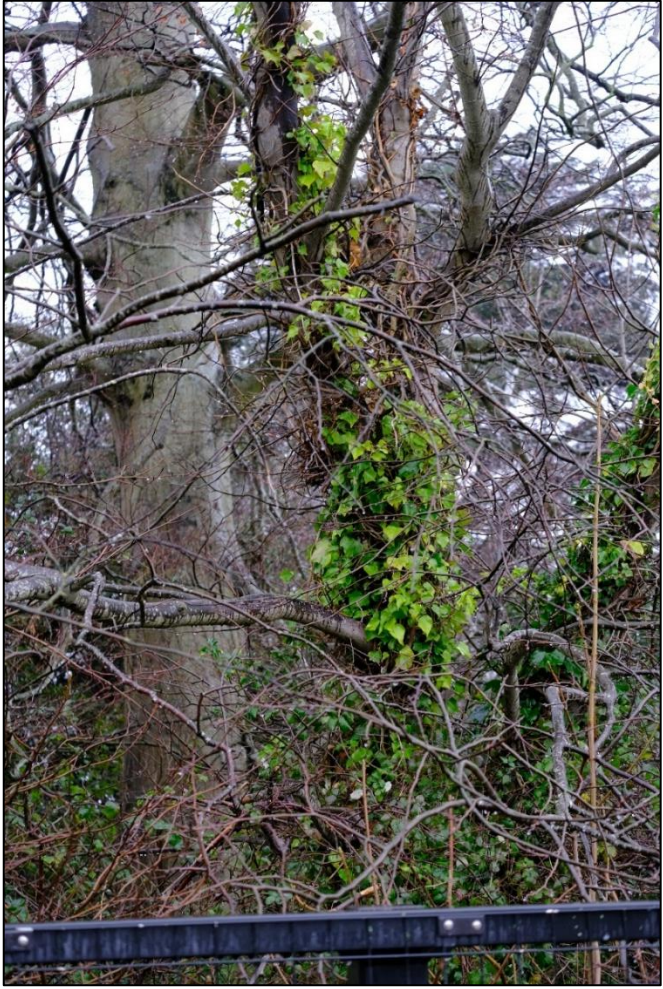
| Tree No. & Location | Bat Roost Potential | Notes | Photos |
|---|---|---|---|
| T13 | No features rated above Negligible suitability for roosting | <p>Group of young trees including Beech, Sycamore, and Elm</p> <p>Young Ivy, some peeling but not very deep</p> | |

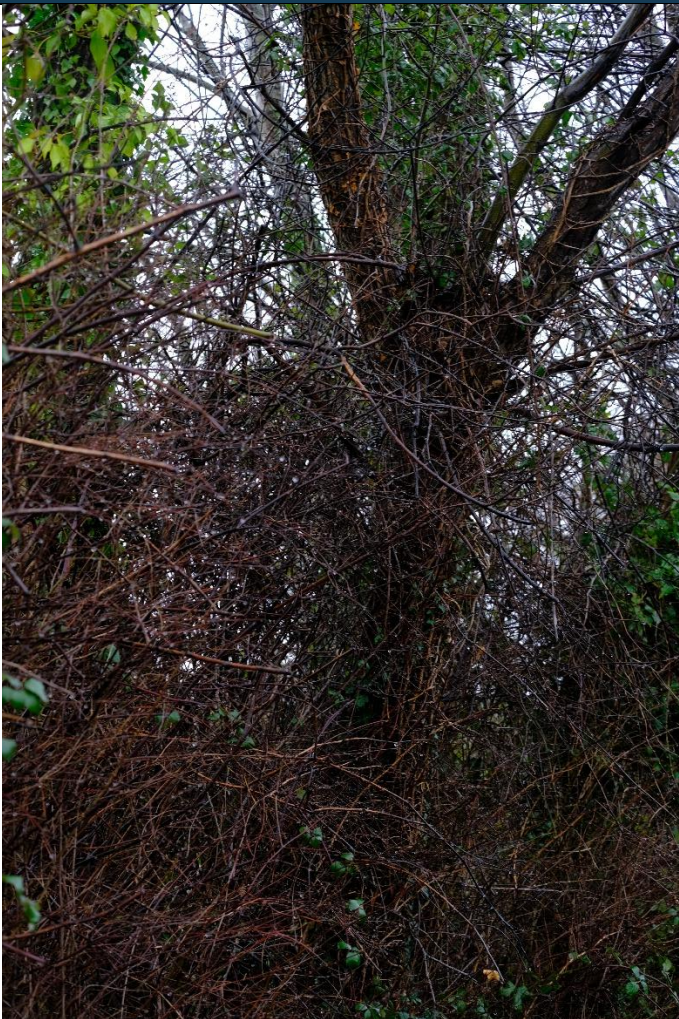
| Tree No. & Location | Bat Roost Potential | Notes | Photos |
|---|---|---|---|
| 1850 | No features rated above Negligible suitability for roosting | <p>Cluster of Willows – early mature</p> <p>Young Ivy is present with patches of mature Ivy</p> <p>Minimal peeling</p> | <p>Example of young Willow in foreground</p> |

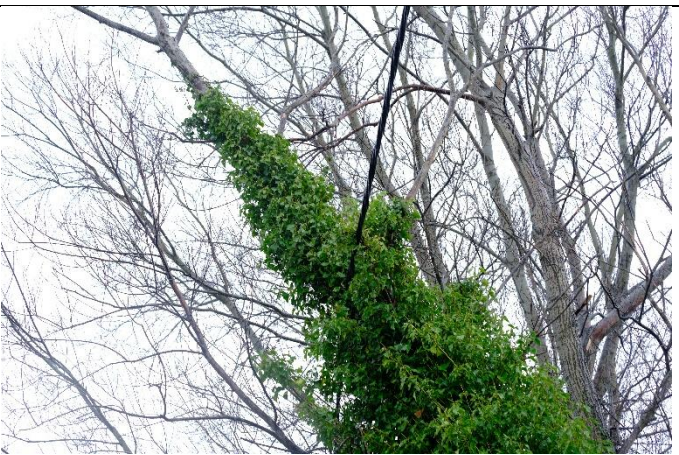
| Tree No. & Location | Bat Roost Potential | Notes | Photos |
|---|---|---|---|
| 1849 | No features rated above Negligible suitability for roosting | <p>Early mature Sycamore in good condition</p> <p>Tree has been recently trimmed; remaining Ivy present is young and sparse</p> | |

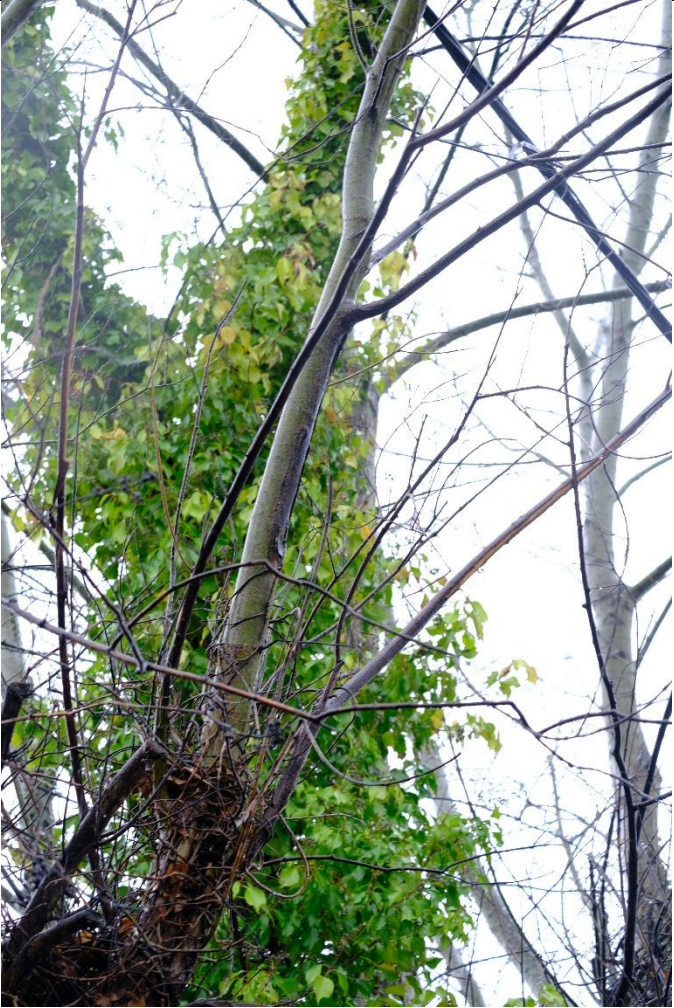
| Tree No. & Location | Bat Roost Potential | Notes | Photos |
|---|---|---|---|
| 1848 | No features rated above Negligible suitability for roosting | <p>Early mature Ash tree in poor condition</p> <p>Peeling is present, and semi-mature Ivy is growing along the main trunk.</p> | |

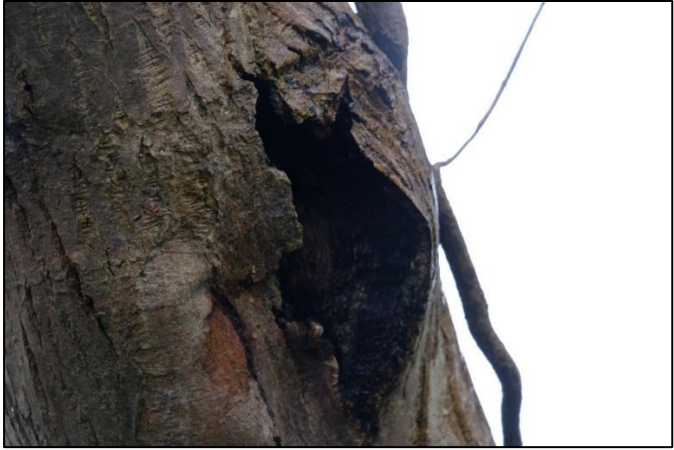
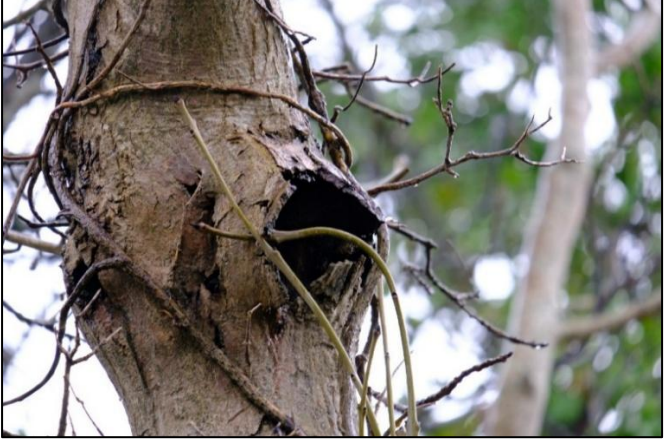
| Tree No. & Location | Bat Roost Potential | Notes | Photos |
|---|---|---|---|
| 1847 | No features rated above Negligible suitability for roosting | <p>Mature Sycamore in good condition</p> <p>Sparse ivy cover which has been cut</p> <p>Two holes are present – not deep enough for bats</p> | <p>Example of one hole present on trunk</p> |

| Tree No. & Location | Bat Roost Potential | Notes | Photos |
|---|---|---|---|
| | | | <p>Example of secondary hole on trunk</p> |

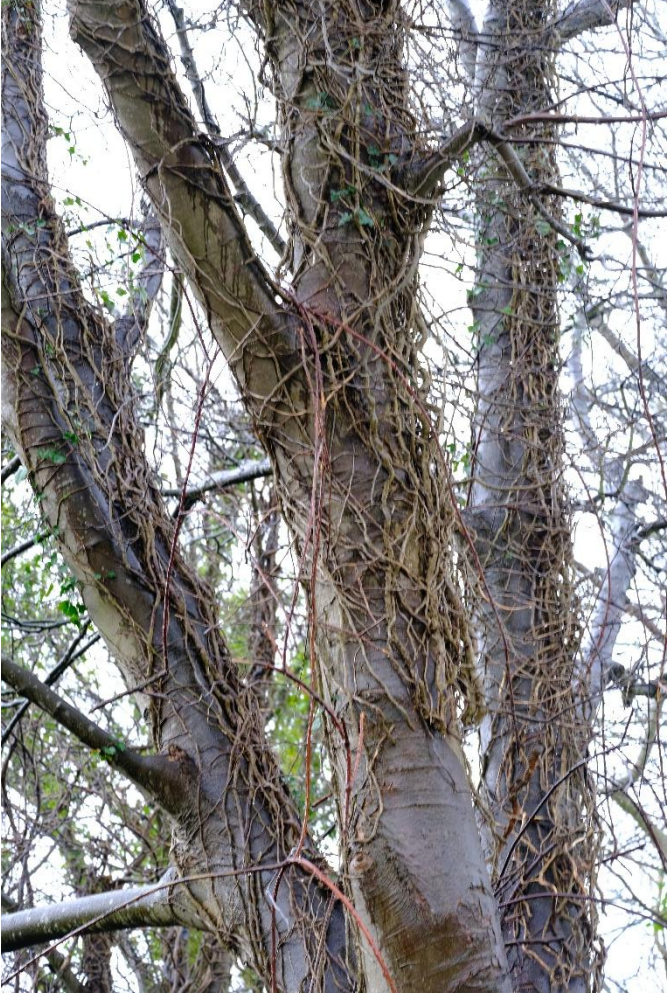
| Tree No. & Location | Bat Roost Potential | Notes | Photos |
|---|---|---|---|
| 1846 | No features rated above Negligible suitability for roosting | <p>Mature Sycamore in good condition</p> <p>Very limited Ivy cover, which has been cut</p> | |

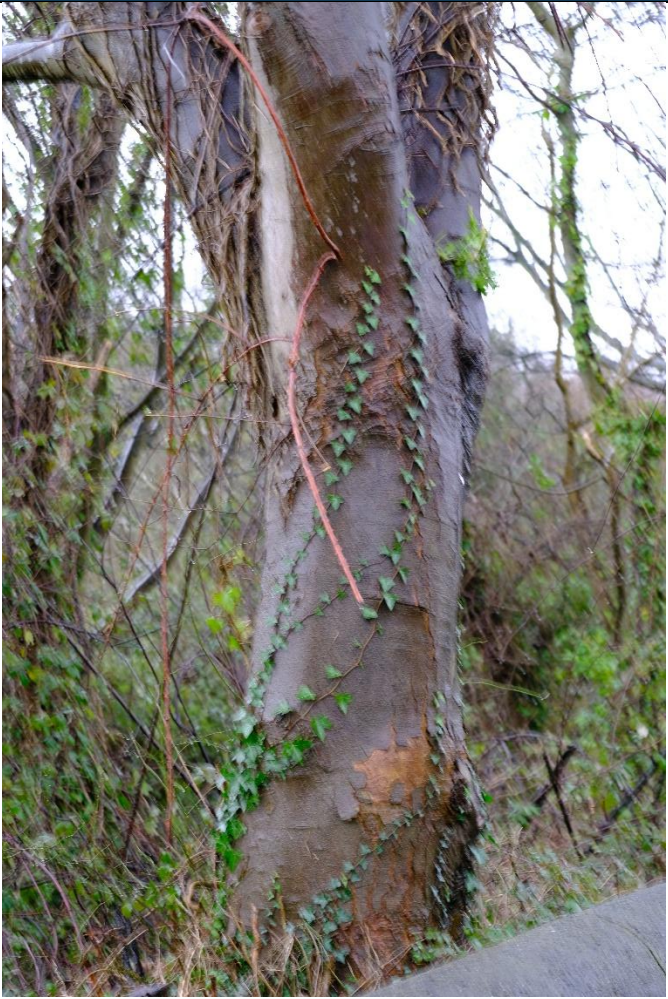
| Tree No. & Location | Bat Roost Potential | Notes | Photos |
|---|---|---|---|
| 1844 | No features rated above Negligible suitability for roosting | <p>Mature Sycamore in good condition</p> <p>Sparse immature Ivy growth</p> | |

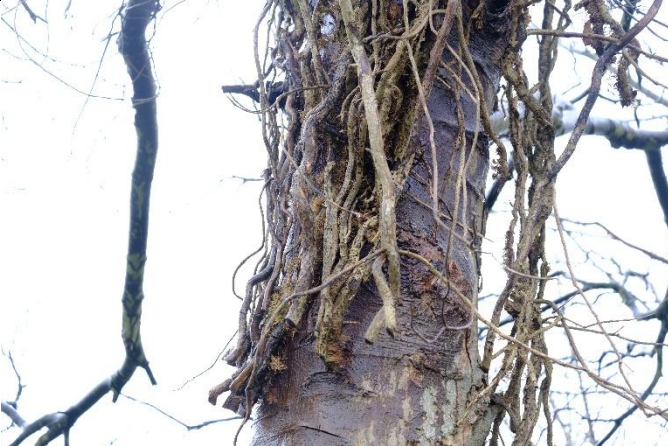
| Tree No. & Location | Bat Roost Potential | Notes | Photos |
|---|---|---|---|
| 1843 | No features rated above Negligible suitability for roosting | <p>Mature Ash in decline, fair condition</p> <p>Young Ivy, recently cut</p> | |

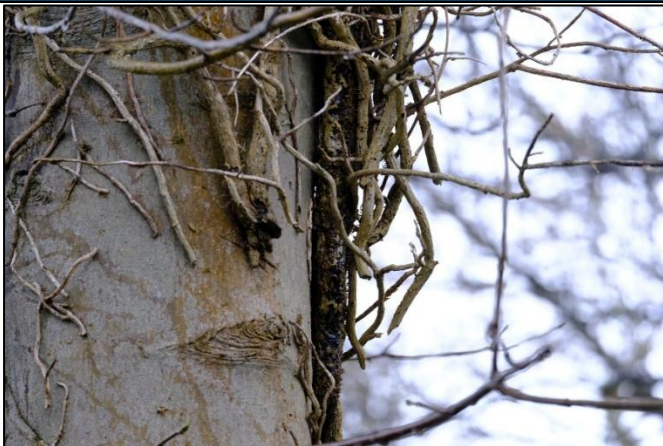
| Tree No. & Location | Bat Roost Potential | Notes | Photos |
|---|---|---|---|
| 1842 | Low potential | Dead Ivy present on trunk with gap available for bats to roost in<br><br>No fissures or peeling | <p>Base of Ivy on tree which has been cut</p> |

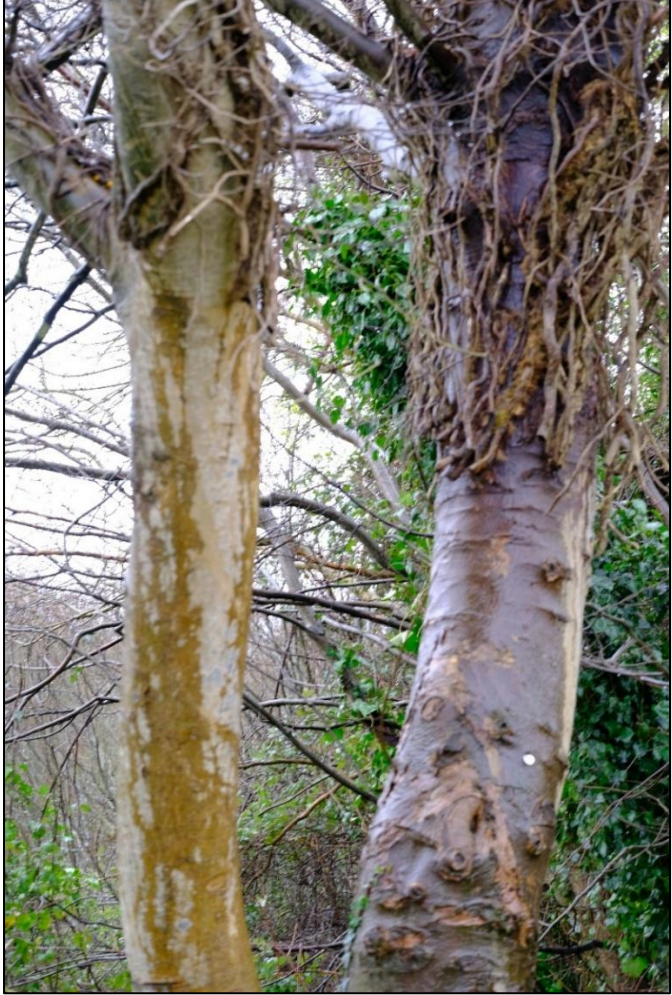
| Tree No. & Location | Bat Roost Potential | Notes | Photos |
|---|---|---|---|
| 1840 | Low potential | Dead Ivy with gap present from main trunk. | <p data-bbox="753 1787 1305 1816">Dead Ivy on trunk that has been cut at its base</p> |

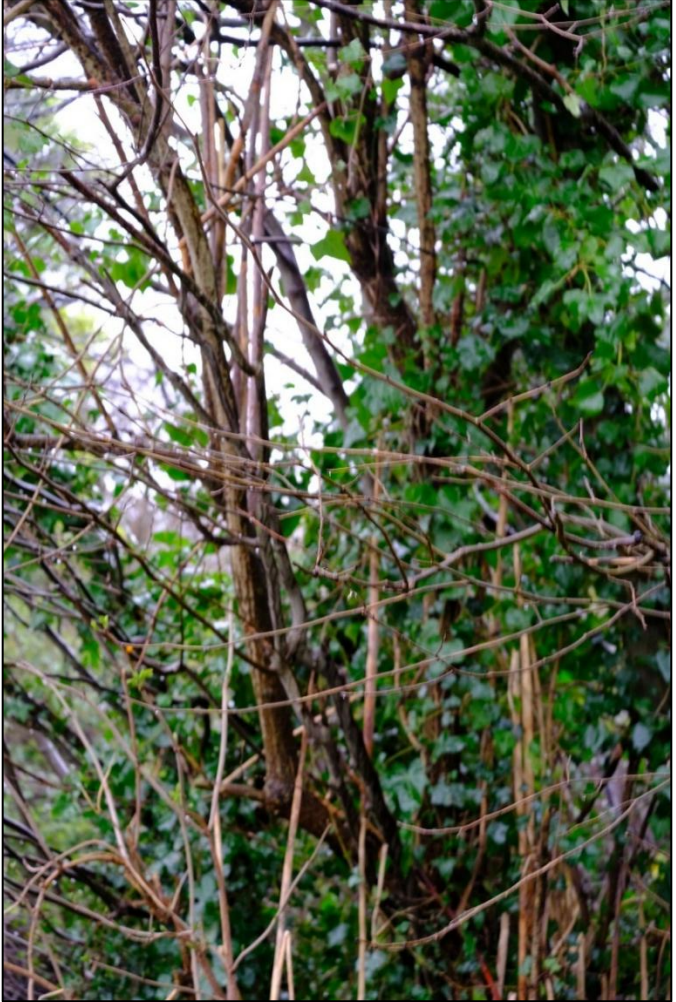
| Tree No. & Location | Bat Roost Potential | Notes | Photos |
|---|---|---|---|
| 1839 | No features rated above Negligible suitability for roosting | <p>Cluster of Hornbeams and Elder.</p> <p>Young ivy present, no real fissures present</p> | |

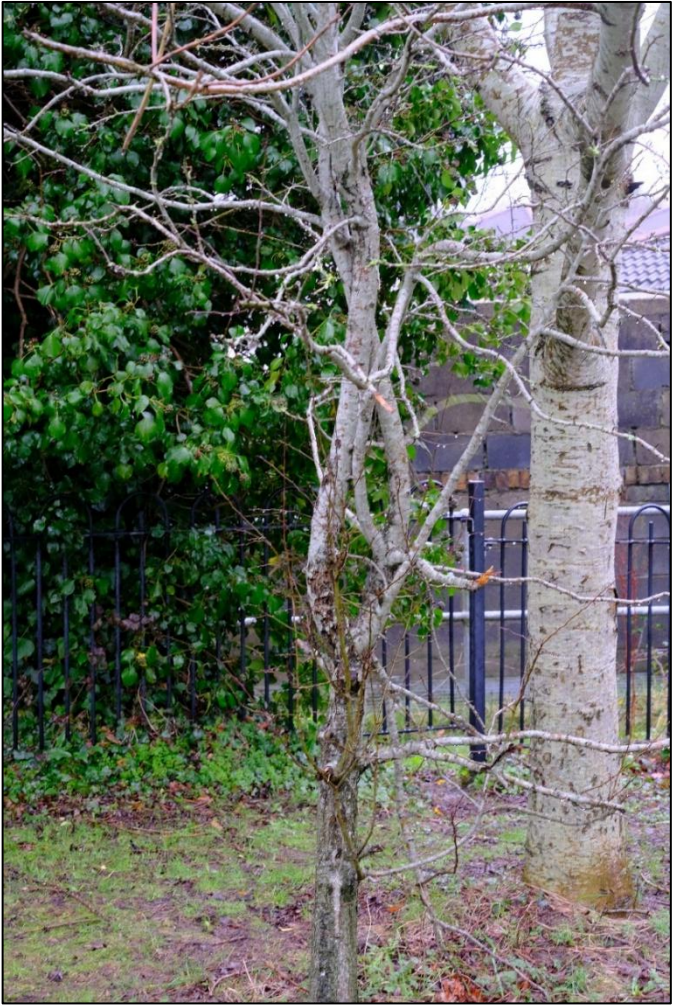
| Tree No. & Location | Bat Roost Potential | Notes | Photos |
|---|---|---|---|
| 1855 | No features rated above Negligible suitability for roosting | Semi-mature Hawthorn – in decline | |

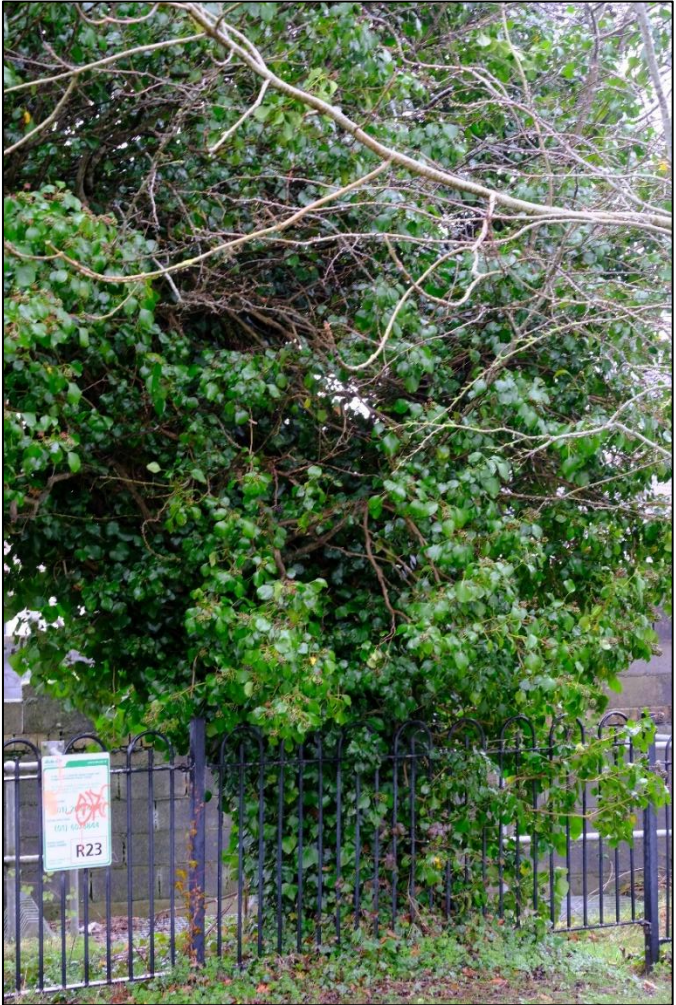
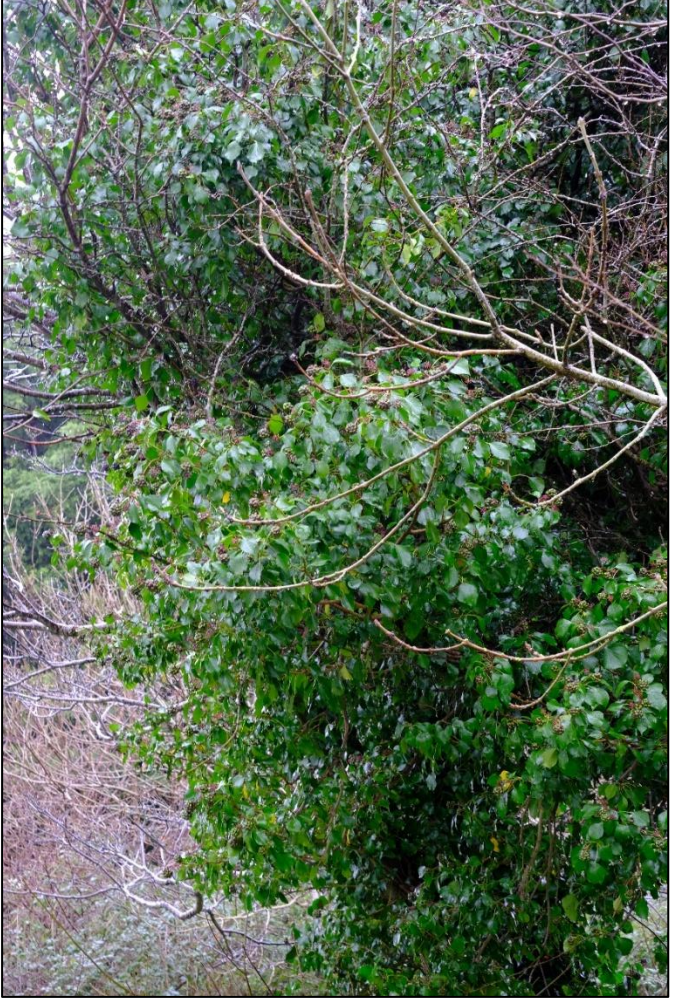
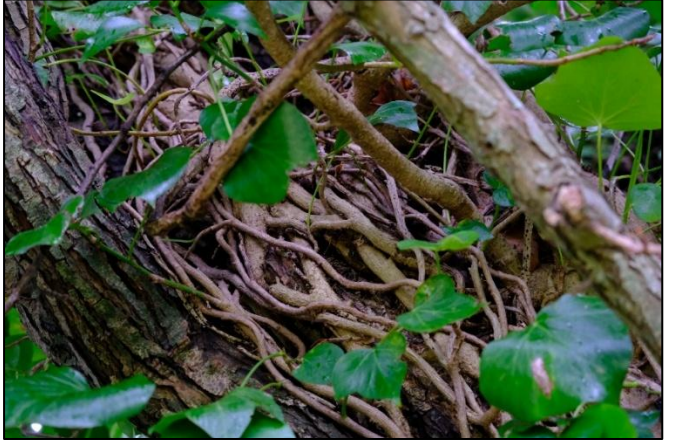
| Tree No. & Location | Bat Roost Potential | Notes | Photos |
|---|---|---|---|
| T20 x 2 | Low potential | <p>Hawthorn on right, Sycamore on left.</p> <p>Extensive Ivy growth present on both, some of which is mature and thick.</p> <p>Low suitability on hawthorn due to ivy growth and interwoven branches – hard to be certain due to visibility issues</p> <p>Bird box (Robin/Spotted Flycatcher) present on Sycamore – needs to be relocated. Healed wounds also present – no features present on Sycamore</p> | <p>Hawthorn on right</p> |

| Tree No. & Location | Bat Roost Potential | Notes | Photos |
|---|---|---|---|
| | | | <p data-bbox="751 1305 954 1339">Sycamore on left</p> <p data-bbox="751 1910 1038 1944">Ivy growth on Sycamore</p> |

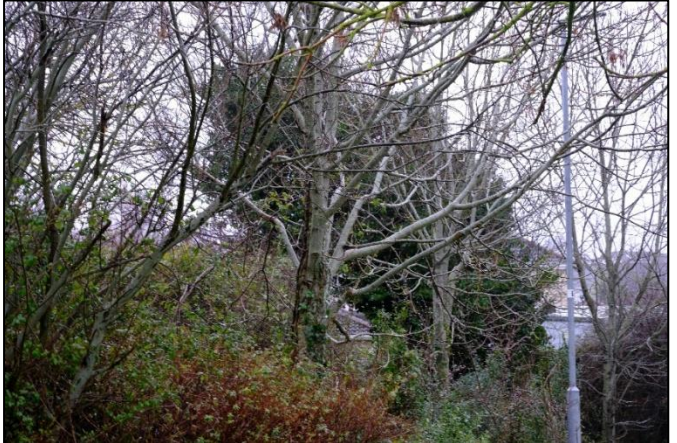
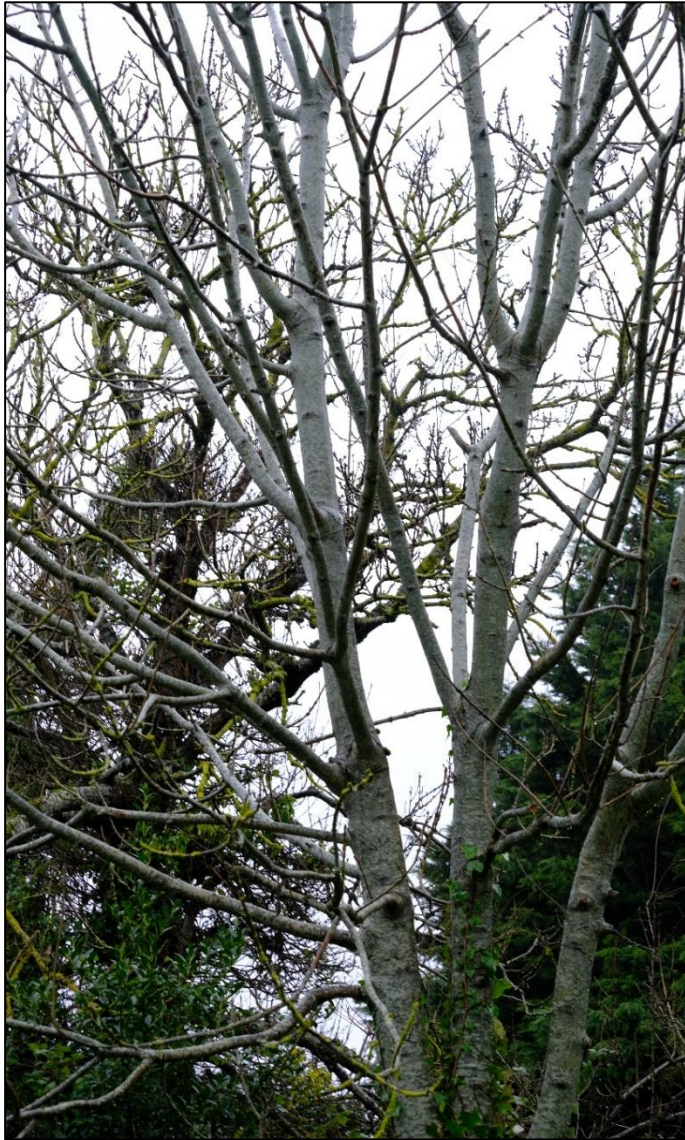
| Tree No. & Location | Bat Roost Potential | Notes | Photos |
|---|---|---|---|
| 1854 | No features rated above Negligible suitability for roosting | Early mature Ash – few wounds present with minimal ivy growth. No suitable cavities for bats. | |

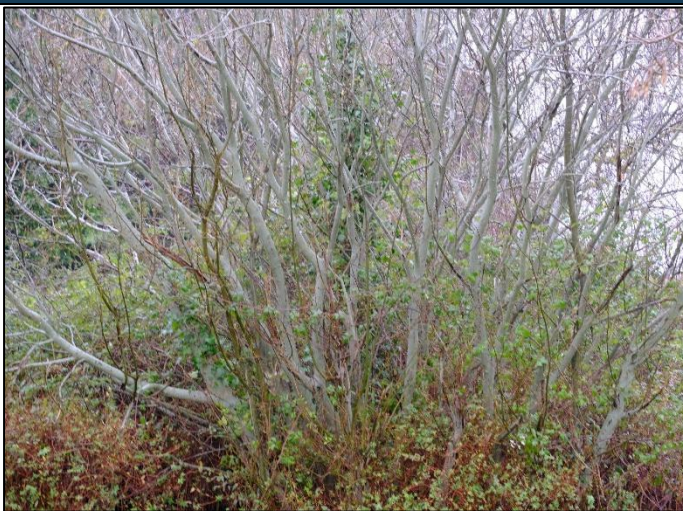
| Tree No. & Location | Bat Roost Potential | Notes | Photos |
|---|---|---|---|
| 1853 | No features rated above Negligible suitability for roosting | <p>Early mature Ash – good condition</p> <p>Minor wounds, some of which have healed</p> <p>Minor ivy growth</p> | |

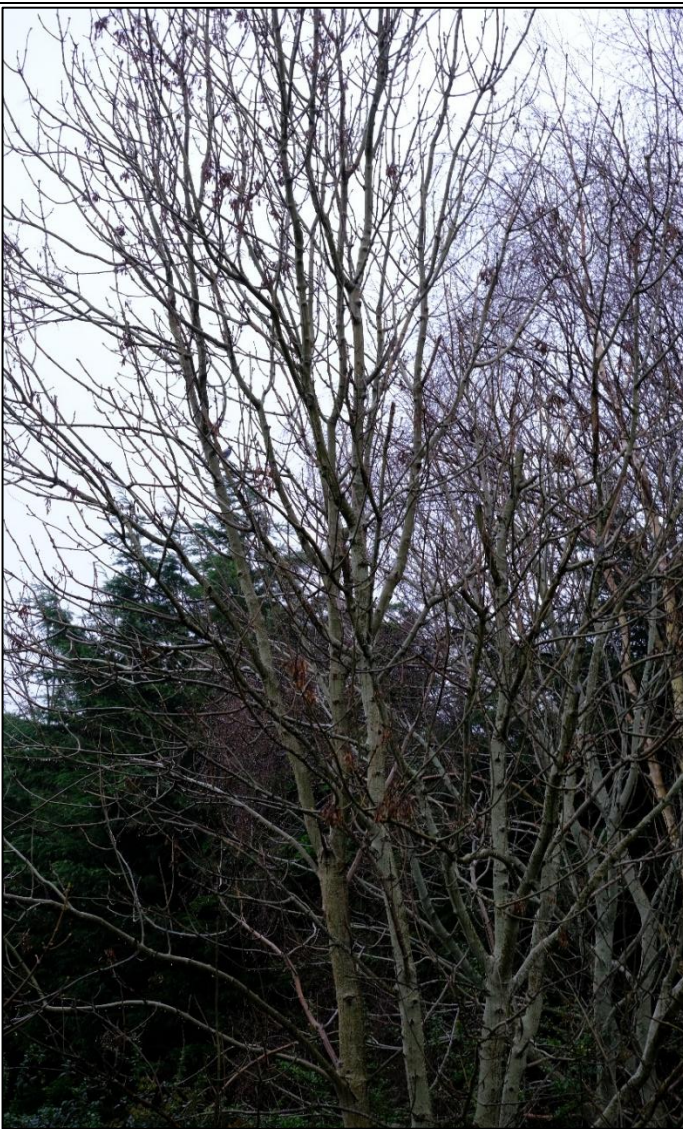
| Tree No. & Location | Bat Roost Potential | Notes | Photos |
|---|---|---|---|
| T19 | No features rated above Negligible suitability for roosting | <p>Early mature tree</p> <p>Limb breaks present with minor wounds – however none are suitable for roosting bats as they are all vulnerable to rainfall and are partially healed, leaving no cavities</p> | |

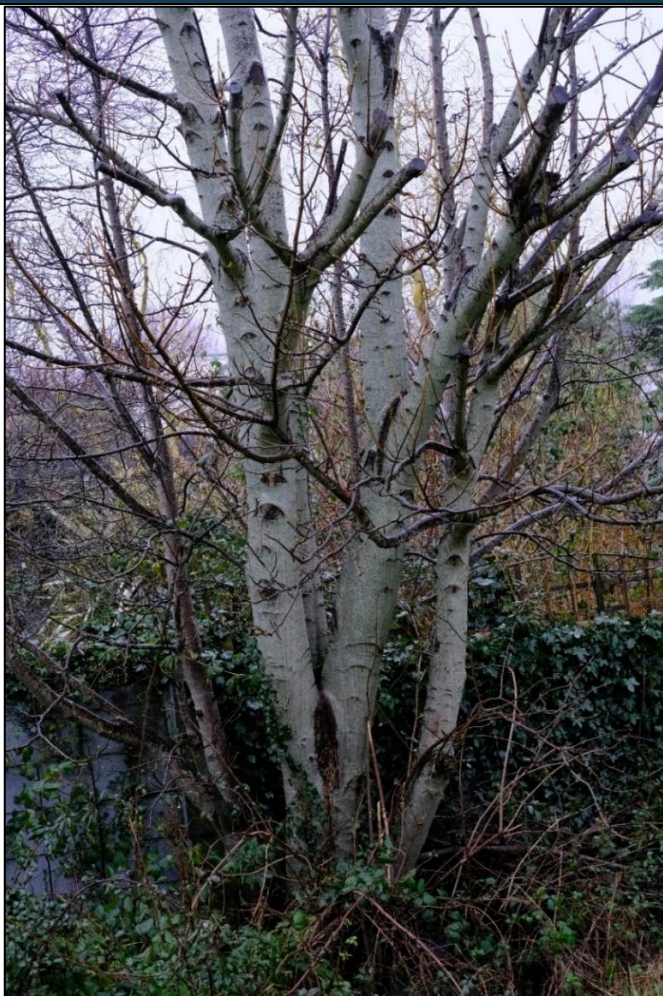
| Tree No. & Location | Bat Roost Potential | Notes | Photos |
|---|---|---|---|
| 1851 x 2 | No features rated above Negligible suitability for roosting | Sycamore on left, Ash on right – no features in either | |
