# Carrickmines-Shanganagh River Flood Relief Scheme

## Bat Roost & Activity Assessment

Final Report

August 2026

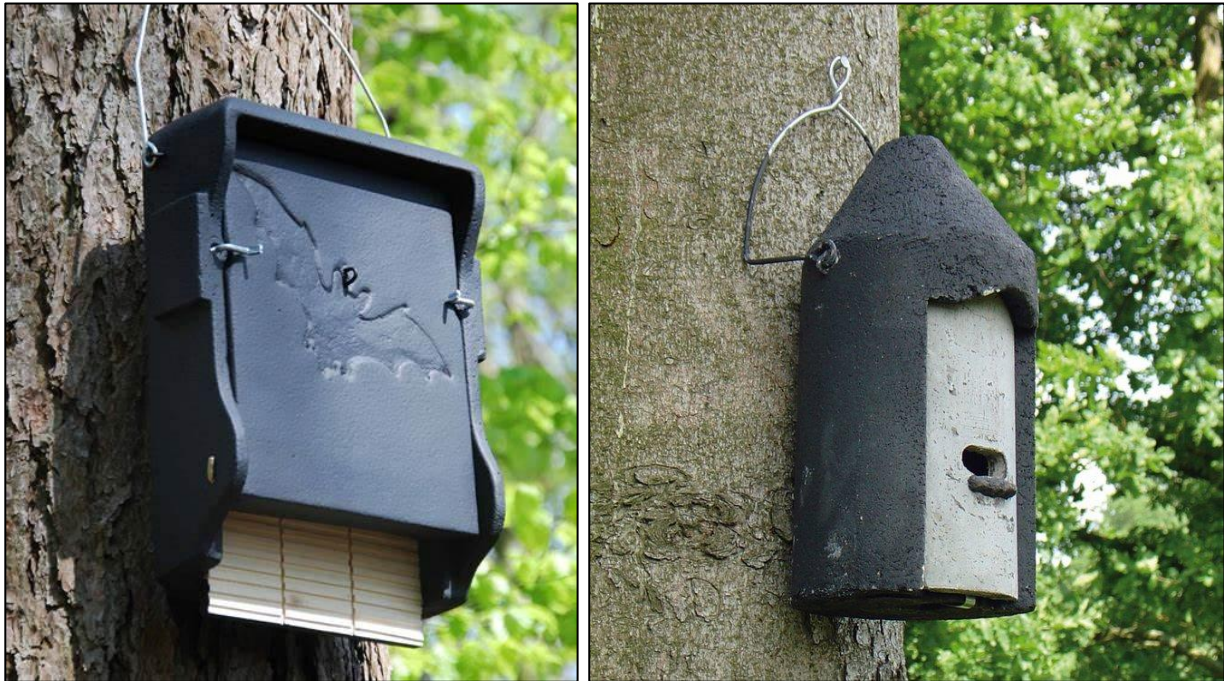
Figure 6-1: Examples of 1FF Schwegler Bat box (right) and 2F Schwegler Bat box (left).

- Suggested locations include areas with mature trees within treelines.
- All bat boxes will be mounted at least 4 metres above the ground.
- Mount on the south facing site of the tree where the box is exposed to the sun for part of the day.
- Do not install bat boxes on a tree that is near any lighting column.
- If erecting a bat box on a building, erect as close as possible to the eaves of the building, and on building located adjacent or close to a treeline.
- If erecting on a mature tree, the placement must be free from Ivy with no branches within a 1m radius around the location of the box.

These specifications are generalised; and a bat specialist or suitably qualified ECoW will need to be consulted to provide more definitive advice on how and where to appropriately install these bat roost boxes along the scheme sections.
